CHAPTER VI

MATERIALS CONSERVATION ANALYSIS

The materials conservation analysis on the Housing and Urban Development (HUD) Building at 451 7th Street, SW, Washington, DC (Building #DC0092ZZ), was prepared between June and December of 1994. The purpose of this analysis is to provide the information required to stabilize, preserve, restore and maintain the significant materials of the building. Restoring and preserving the original appearance of the building's materials and details will return the building to its original appearance, thus expressing the original intent of the administration and designers who created the building. Proper maintenance will preserve the appearance of the materials, thus slowing the rate of deterioration and substantially extending the building material's life.

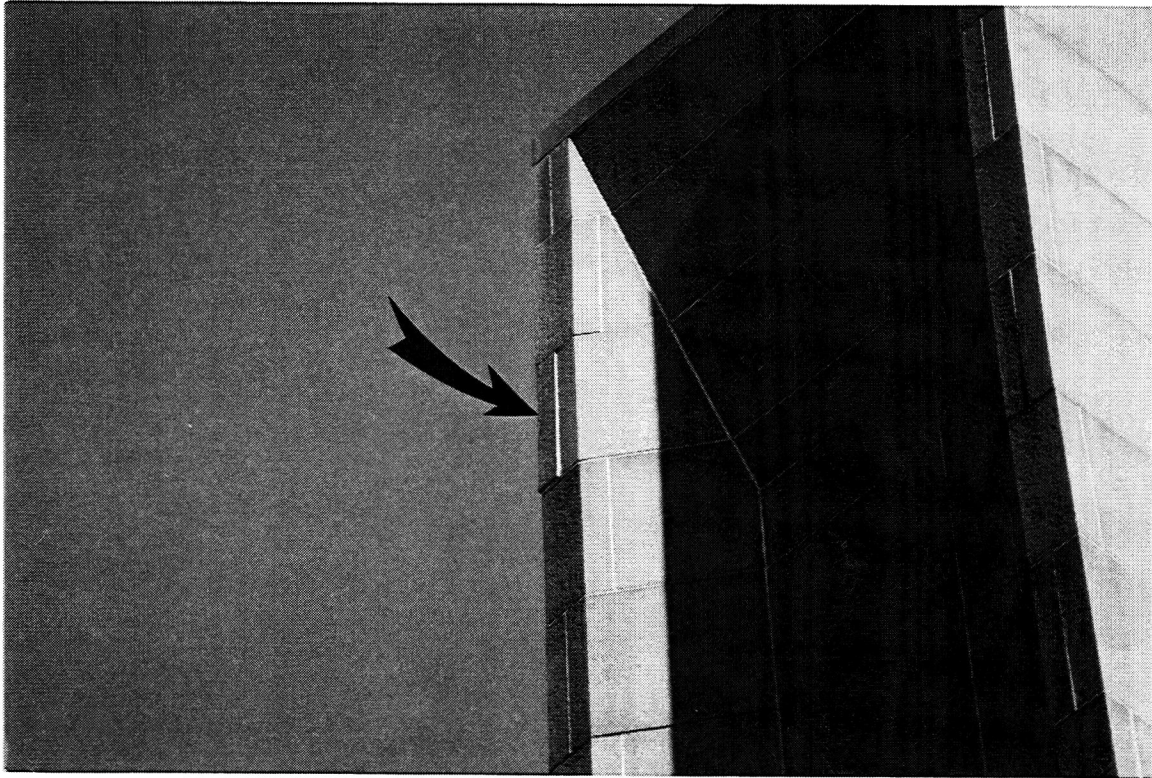
Illustration No. 6-1

Several of the granite panels at the tops of the walls of the corner stair towers are dislocated (Illus. No. 6-1). This movement was probably caused by water in the wall freezing and forcing the panel out of alignment. There does not appear to be any water entering the wall at this time.

- ◆ Inspect dislocated panels. Inspect the panels that are out of alignment to determine the cause of the movement and the condition of the anchors. This option may require further work.
- ◆ Remove and reinstall dislocated granite panels. Because the panels are only slightly out of alignment, they are not noticeable from the ground. Removal and reinstallation is only necessary if the anchorage needs to be replaced.

- ◆ Clean the granite walls evenly and remove stains and soiling following the procedures under Chapter X, Guideline Specification for "Exterior Masonry Cleaning."
- ◆ Periodically inspect granite walls and remove graffiti. Using trained building maintenance personnel, follow tested and approved methods to remove the graffiti without damaging the granite. See Chapter X, Guideline Specification for "Exterior Masonry Cleaning."
- ◆ Install wheel blocks to prevent car bumpers from scuffing the granite walls and car exhaust from staining granite walls. Wheel blocks should be compatible with the existing materials, design and detailing of the building.
- ◆ Inspect the panels that are out of alignment to determine the cause of the movement, the extent of the movement and the condition of the anchors.

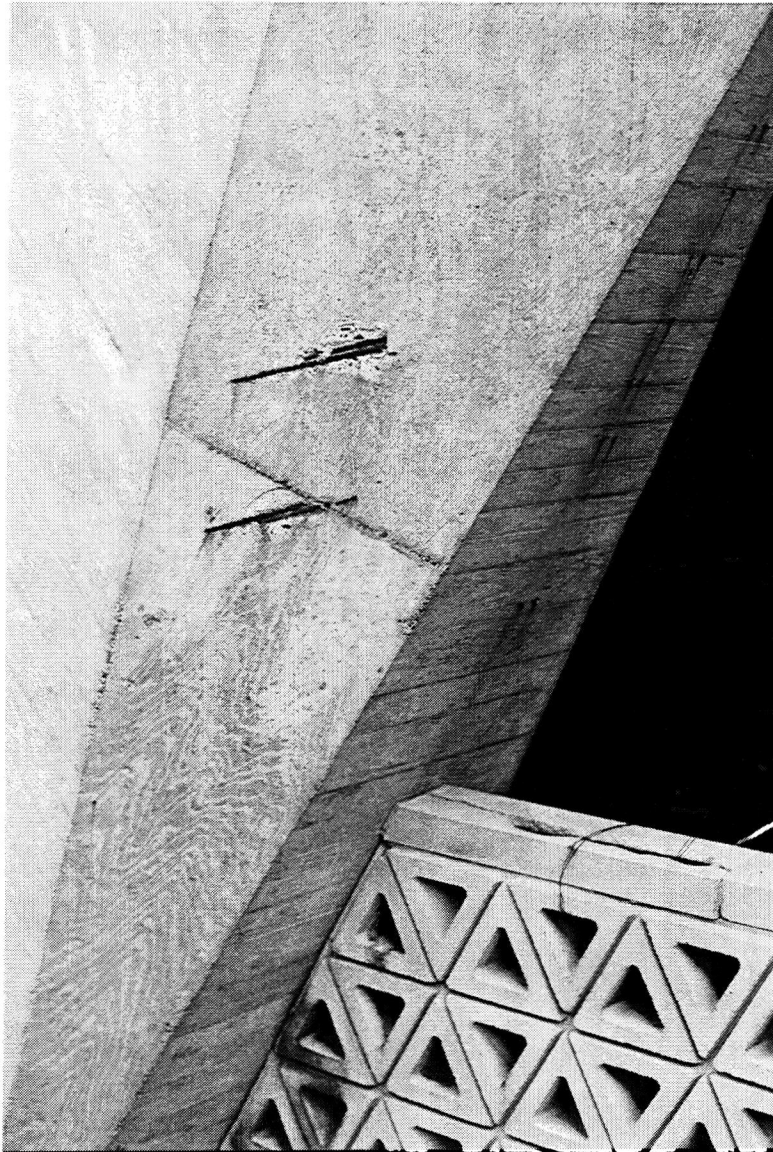
Illustration No. 6-4

Spalling from corroding steel reinforcing occurs in the sides and faces of many of the concrete pilotis (Illus. No. 6-4). Corrosion of the reinforcing in the precast copings of the screen walls has caused many of the copings to crack into two pieces (Illus. No. 6-4). Several of these copings are missing and several have been replaced with precast concrete lintels (Illus. No. 6-11). There are several minor spalls on the precast concrete wall panels probably caused by corroding steel reinforcing in the wall (Illus. No. 6-5). The cause of the spalling of the concrete is an insufficient cover of concrete over the steel. Moisture has penetrated the thin layer of concrete covering the steel and caused the reinforcing steel to corrode and expand in volume which forces the outer thin layer of concrete to spall off. (These spalling pieces of concrete will eventually fall and may damage the cars parked below or hit pedestrians.)

- ◆ **Patch Spalled Concrete.** Patching the spalled concrete requires that the deteriorated concrete be removed, the corrosion removed from the steel and the steel coated to prevent it from corroding. A concrete patch must be placed to re-embed the steel and protect it from moisture and corrosive elements in the environment. On the architectural concrete surfaces, the patches must duplicate the appearance of the concrete color, surface texture, wood grain pattern and joint patterns. Where the steel is close to the surface of the concrete, additional corrosion protection must be applied to the steel instead of mounding up the patch material to provide the required thickness of cover over the steel.

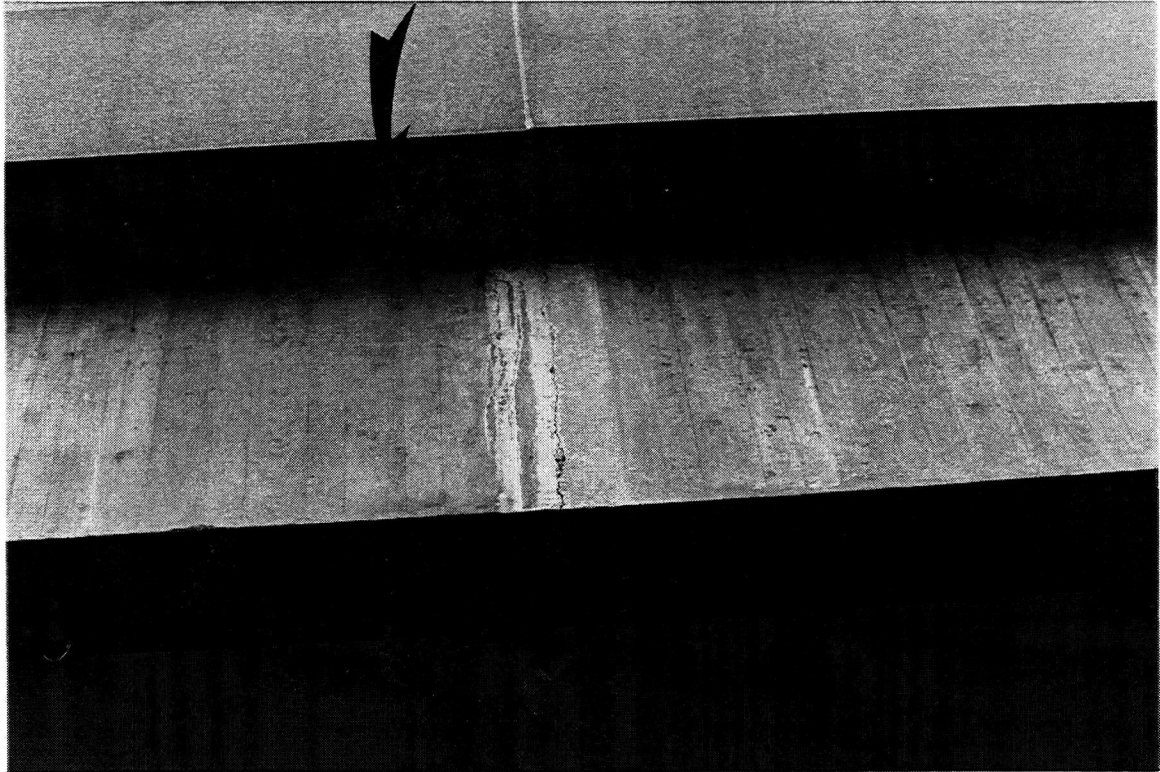
Illustration No. 6-8

Concrete beams under the northwest corner of the building at the second floor level that support the corner stair tower are cracked in their centers (Illus. No. 6-8). The cracks are hairline on one beam and are very narrow, $\pm 1/6$ inch wide. The cracks are caused by the forces on the concrete beam exceeding the tensile strength of the concrete. As a result the concrete beam cracked at its center, at the location of the maximum tensile stress. The steel reinforcing is resisting the tensile stresses in the concrete beam.

- ◆ **No Treatment.** The crack in the concrete does not effect the structural stability of the beam because the tensile stresses in the beam are being resisted by the steel reinforcing. The crack does, however, provide a path for air and moisture to access the interior of the concrete and react with the steel reinforcing. No treatment will allow the moisture and air to corrode the steel resulting in iron stains on the concrete, spalling of the concrete and eventually compromising the structural stability of the beam.
- ◆ **Repair Crack.** Filling the crack will not increase the structural capacity of the beam but will prevent moisture and air from penetrating the beam and causing the deterioration of the reinforcing steel and concrete.
- ◆ **Replace Beam.** Stabilization of the beam can be achieved by filling the crack. Replacement of the beam is not necessary.

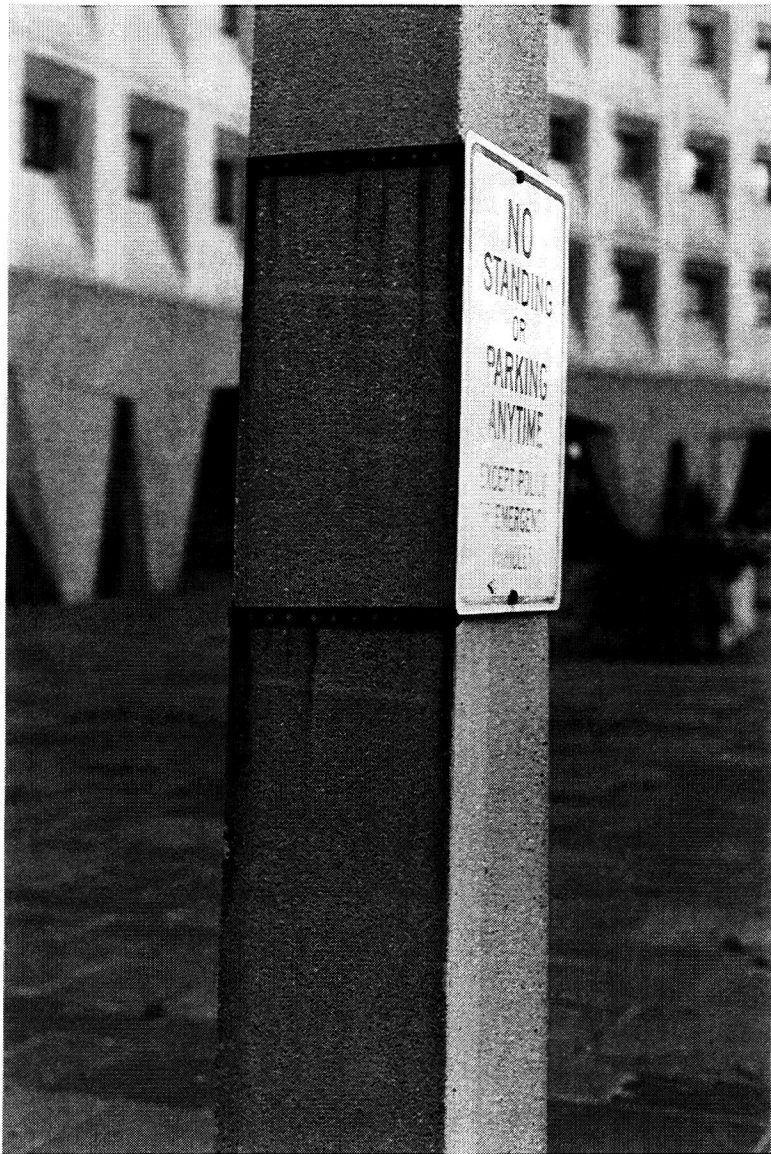
Stains from corroding steel reinforcing and reinforcing bar chairs and supports are found on both the precast and cast-in-place exterior concrete (Illus. Nos. 6-37 - 6-42). This staining appears on a small percentage of the precast concrete wall panels (Illus. No. 6-7) but occurs on all of the concrete pilotis, creating distracting patterns of rust (Illus. No. 6-4). The cause of the corrosion is insufficient concrete cover or lack of concrete cover over the steel. The natural high alkalinity of concrete causes a passivating film to form on the surface of the steel, creating a protective covering over the steel. Lack of concrete cover or thin cover allows the corrosive elements in the environment and moisture to penetrate the concrete and corrode the steel, resulting in the rust stains. Corroding steel bands that have been attached to the precast concrete light standards to attach signs are causing staining on the posts (Illus. No. 6-14).

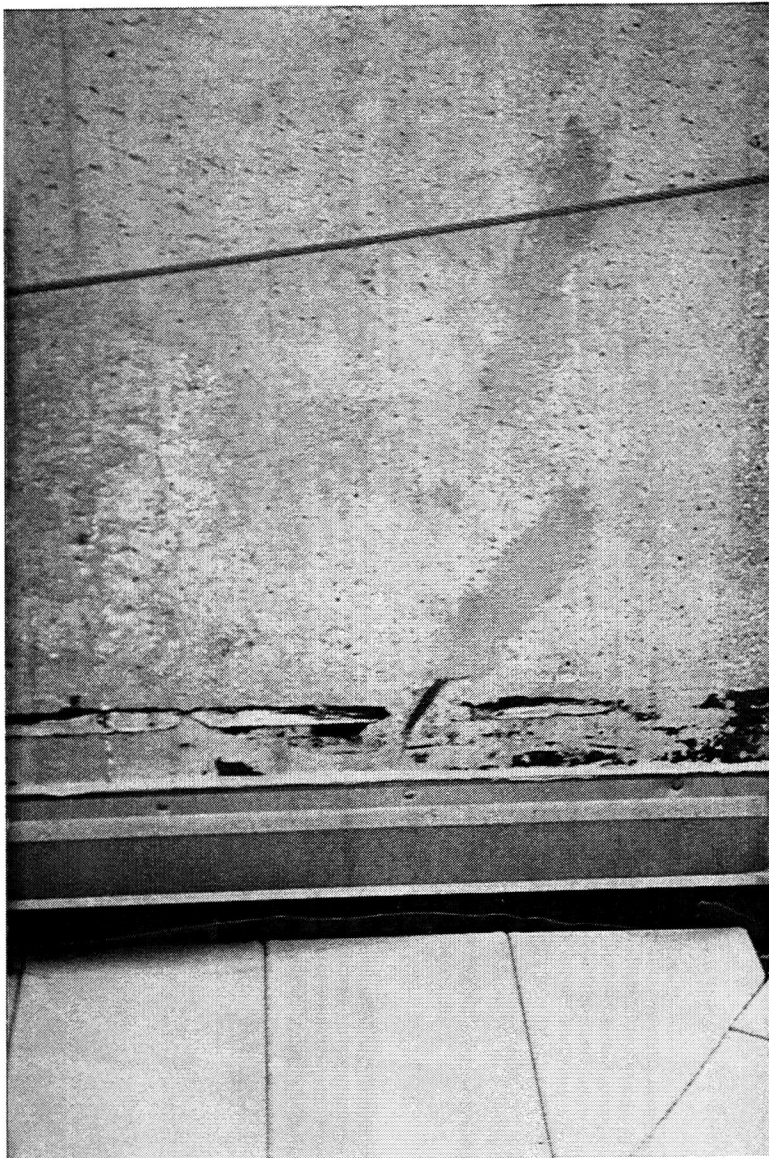
Illustration No. 6-31

Numerous areas on the concrete penthouse walls have been patched with a concrete patch (Illus. Nos. 6-36 - 6-37). Corroding steel reinforcing with insufficient concrete coverage caused the original concrete to spall (Illus. No. 6-31). These spalls were patched with materials not matching the color or surface texture of the original concrete. Several of these patches are now spalling due to the continued corrosion of the steel.

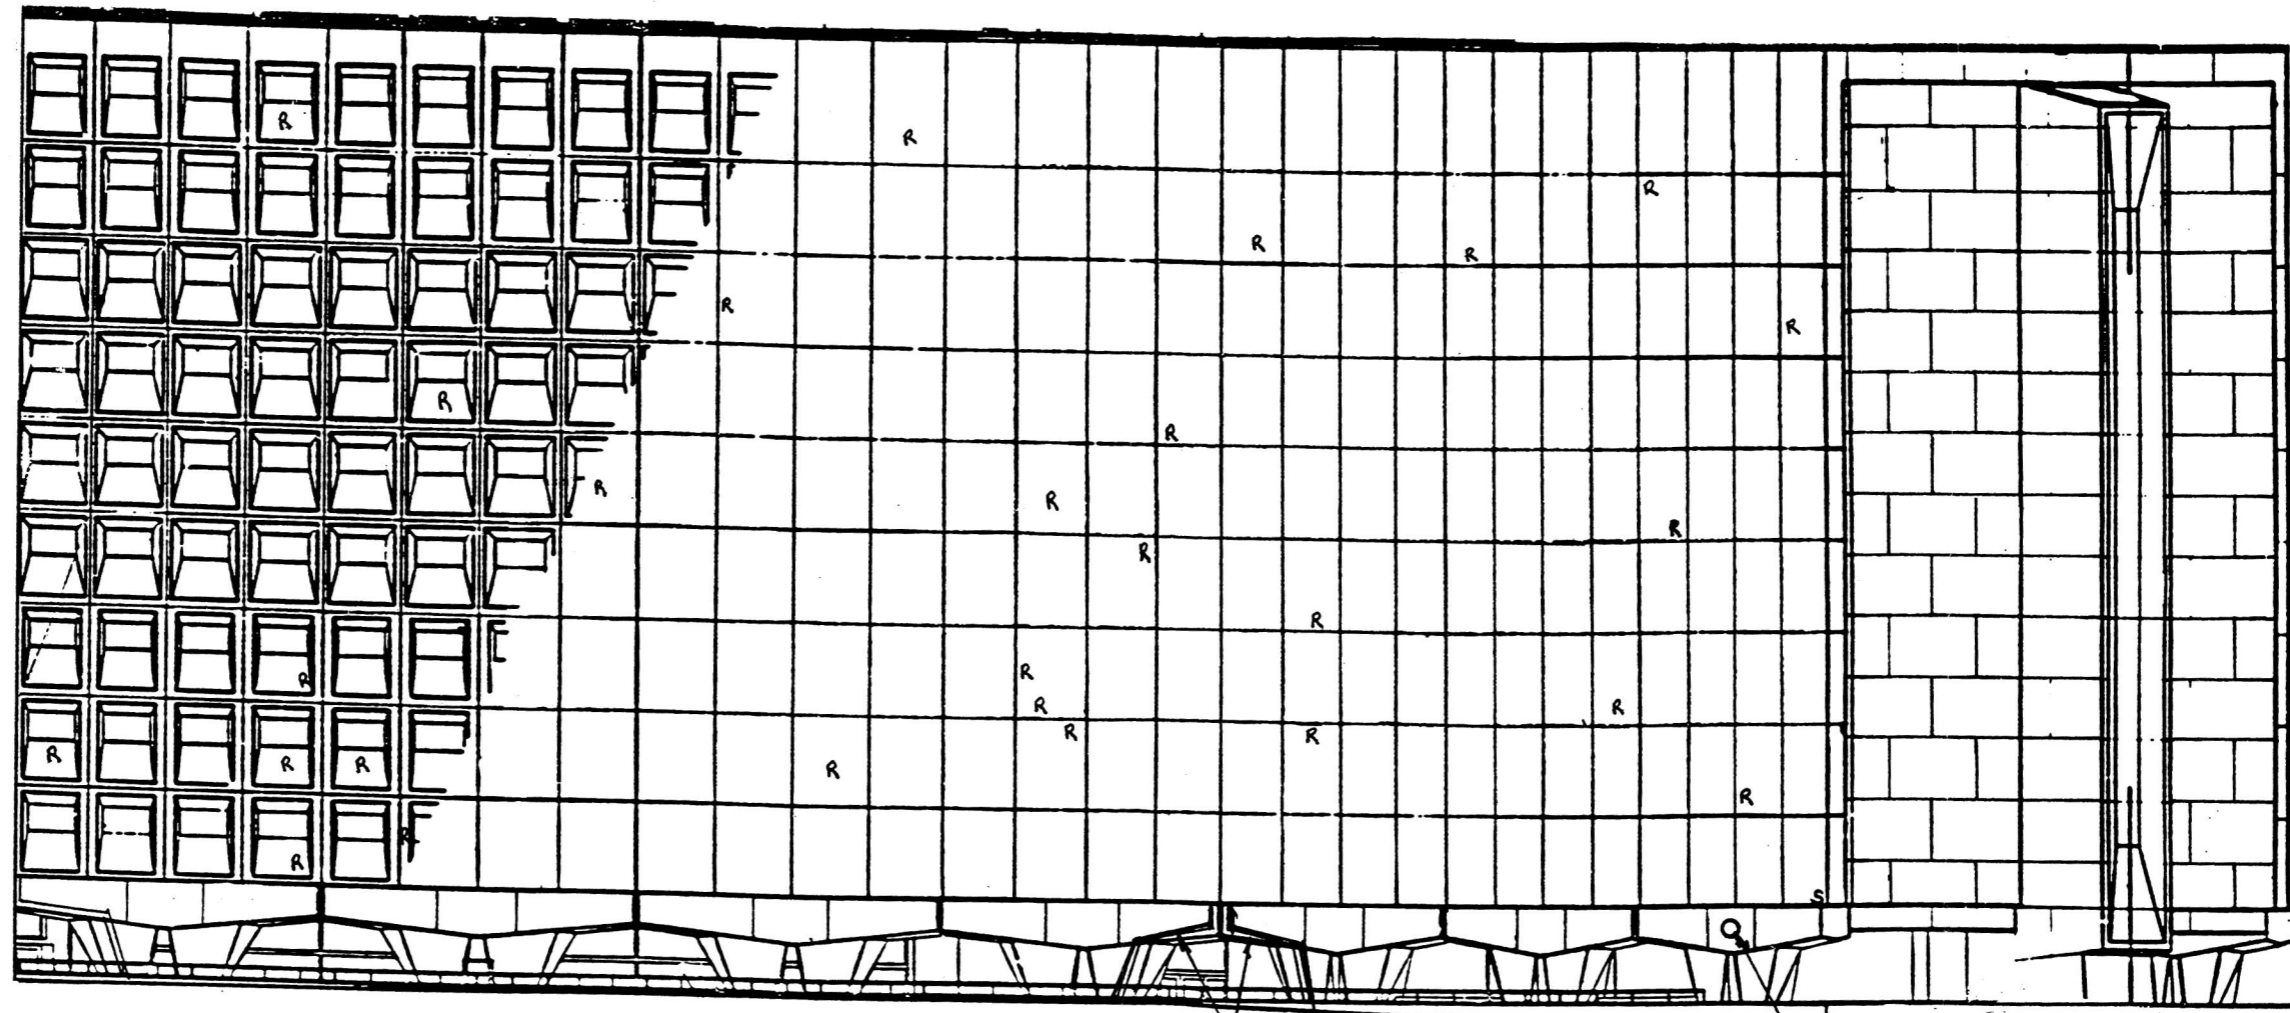
PARTIAL EAST ELEVATION

COPPER GUTTER INSTALLED
ON FACE OF CONCRETE
AT ENTRANCE

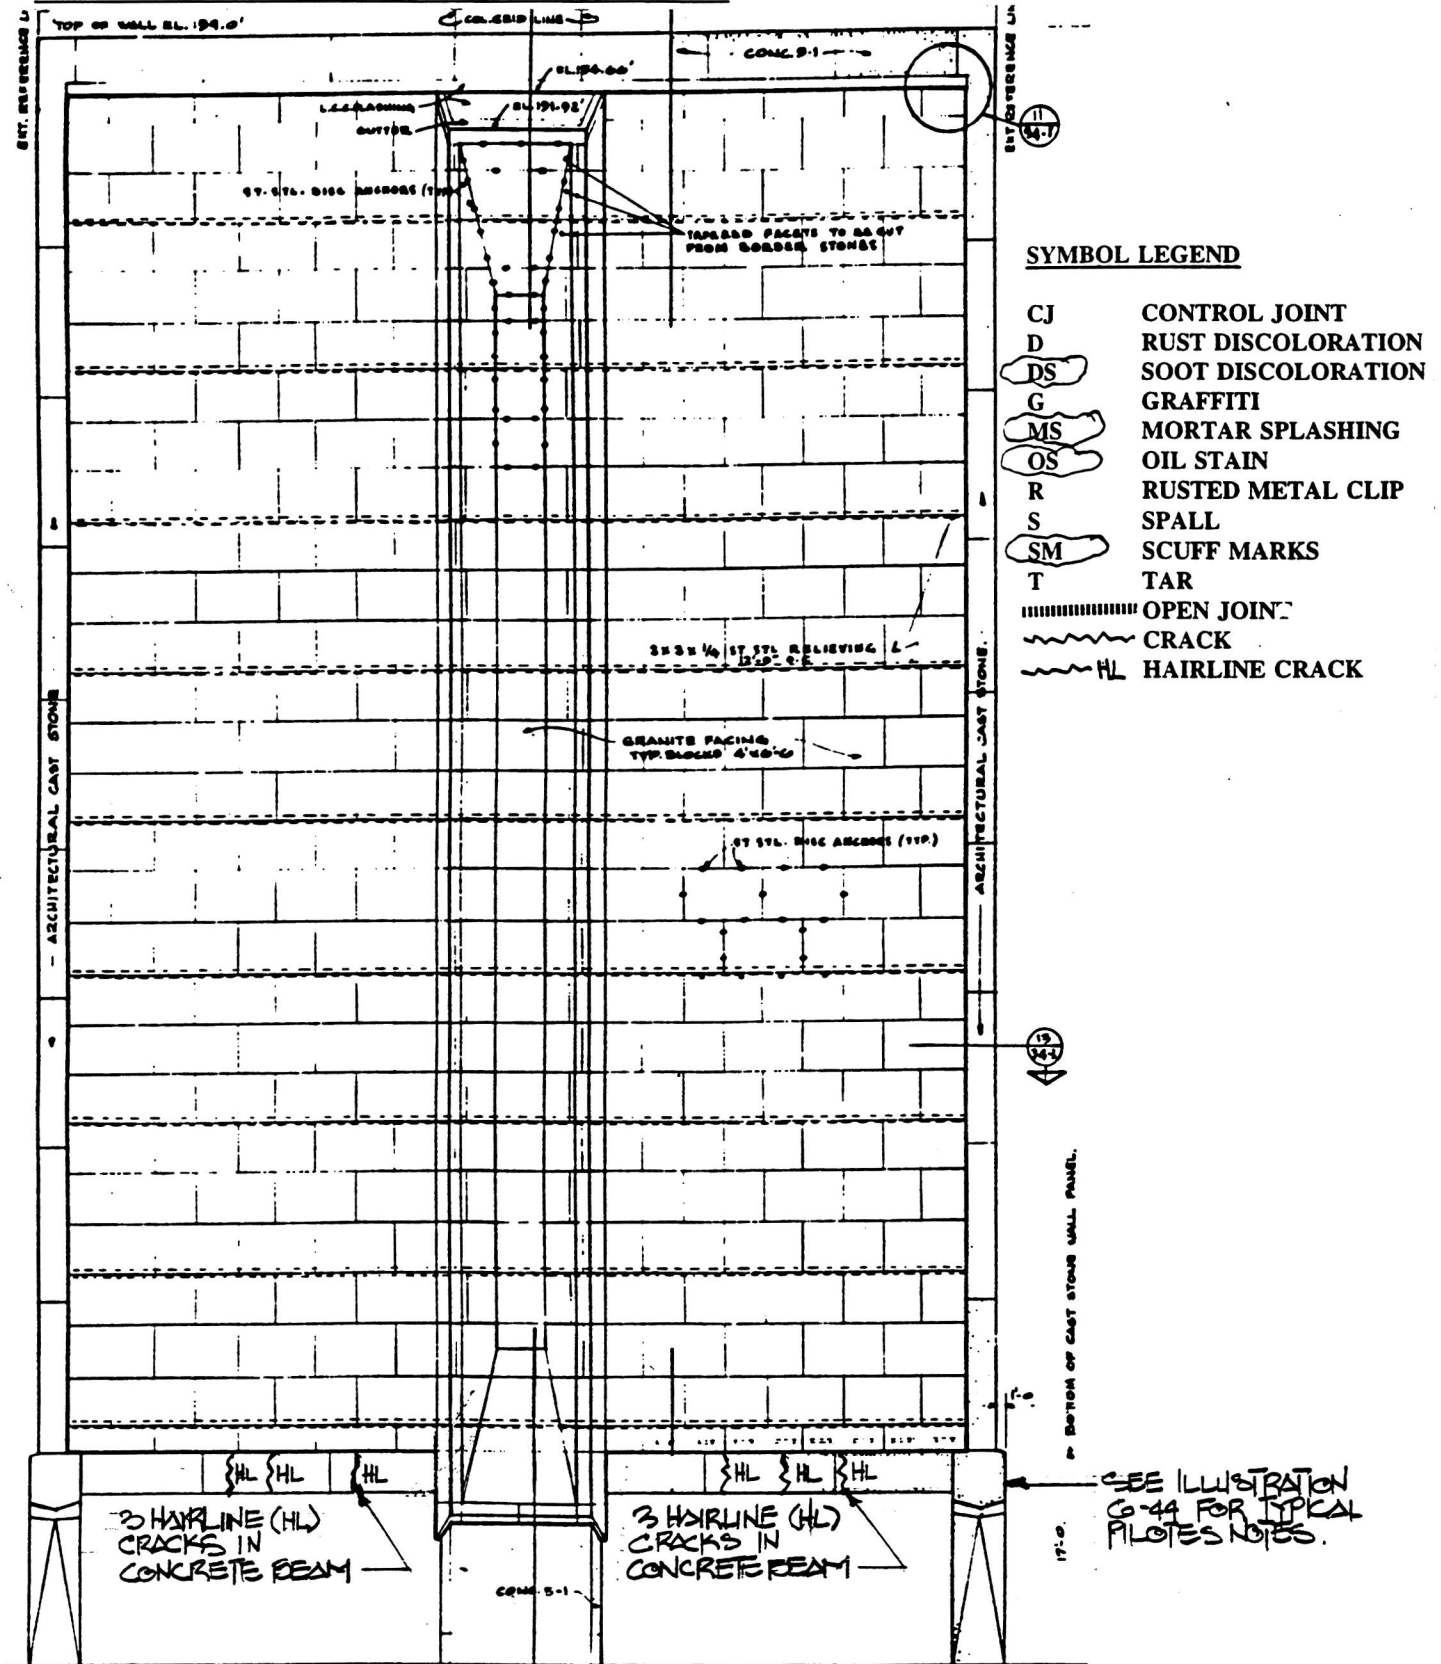
Illustration No. 6-43

The granite end walls of the building are moderately soiled with slight streaking under some of the vertical joints (Illus. Nos. 6-43 - 6-46). The granite clad walls of the first floor are lightly soiled (Illus. Nos. 6-47 - 6-48). These walls are also streaked and appear to have been cleaned unevenly. The granite walls of the first floor are also stained with tape adhesive stains, marker graffiti stains, diesel exhaust stains and glue stains from signage (Illus. No. 6-2). The granite walls are also scuffed from car bumpers and from removal and relaying of the bluestone paving.

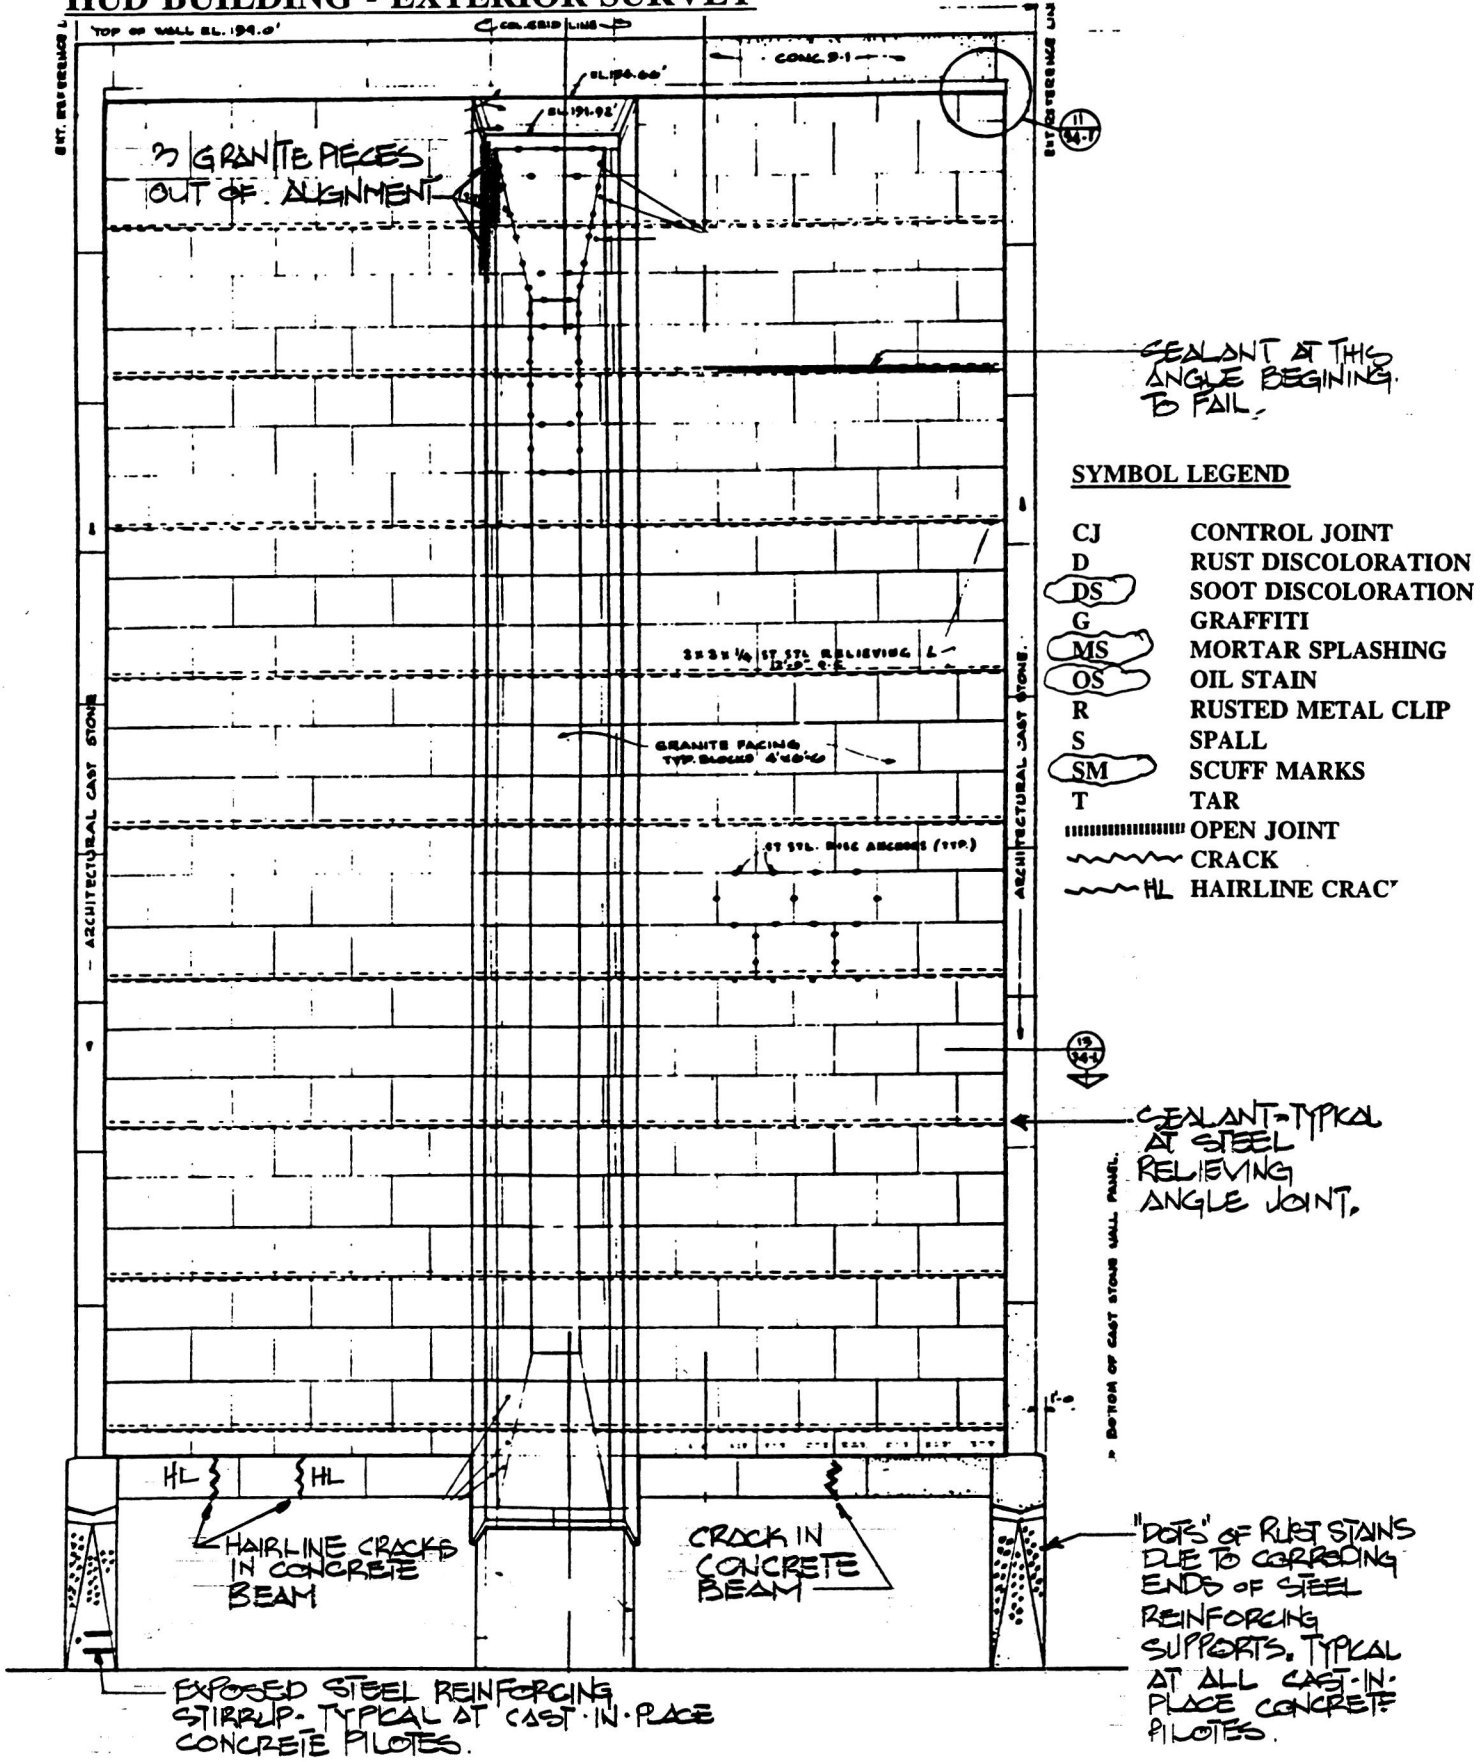
SEALANT AT THIS ANGLE BEGINNING TO FAIL.
