CHAPTER VI

MATERIALS CONSERVATION ANALYSIS

The materials conservation analysis on the Housing and Urban Development (HUD) Building at 451 7th Street, SW, Washington, DC (Building #DC0092ZZ), was prepared between June and December of 1994. The purpose of this analysis is to provide the information required to stabilize, preserve, restore and maintain the significant materials of the building. Restoring and preserving the original appearance of the building's materials and details will return the building to its original appearance, thus expressing the original intent of the administration and designers who created the building. Proper maintenance will preserve the appearance of the materials, thus slowing the rate of deterioration and substantially extending the building material's life.

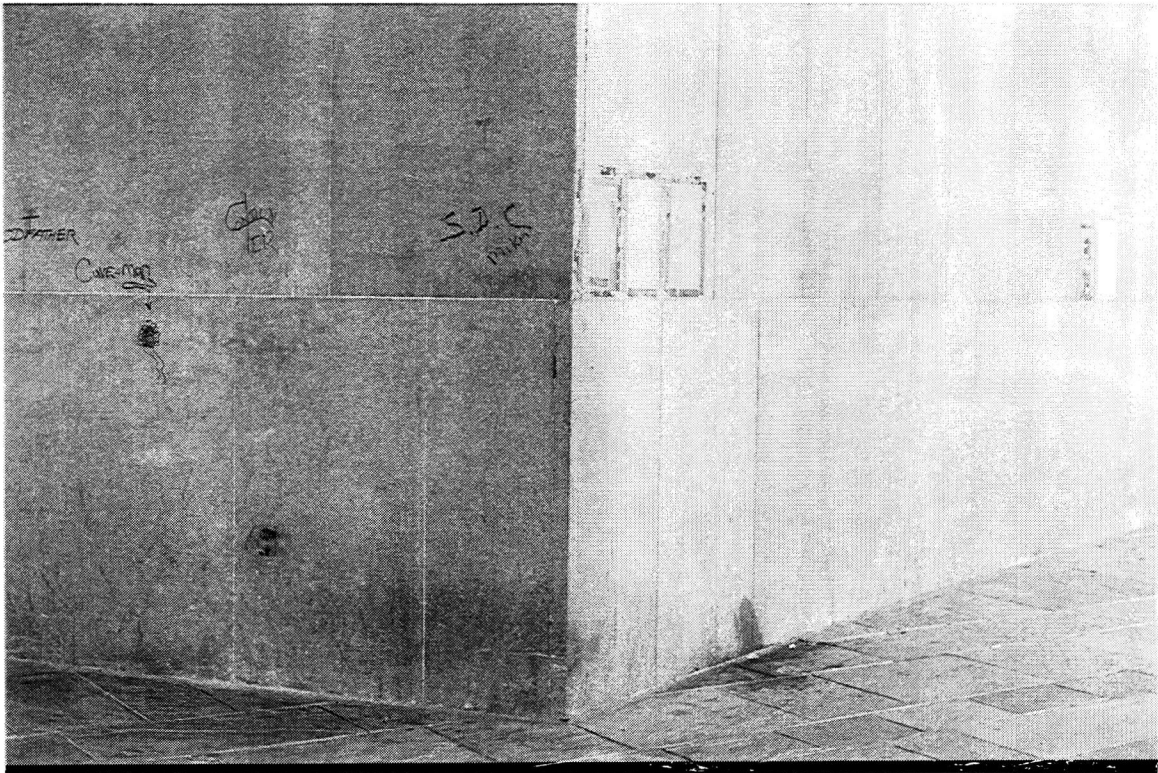
Illustration No. 6-2

Description: Soiled granite panels at southwest corner of the first floor level. Note graffiti, tape marks, soil, sign, urine stains and scuff marks from paving installation (see Chapter X, Guideline Specification for Exterior Masonry Cleaning).

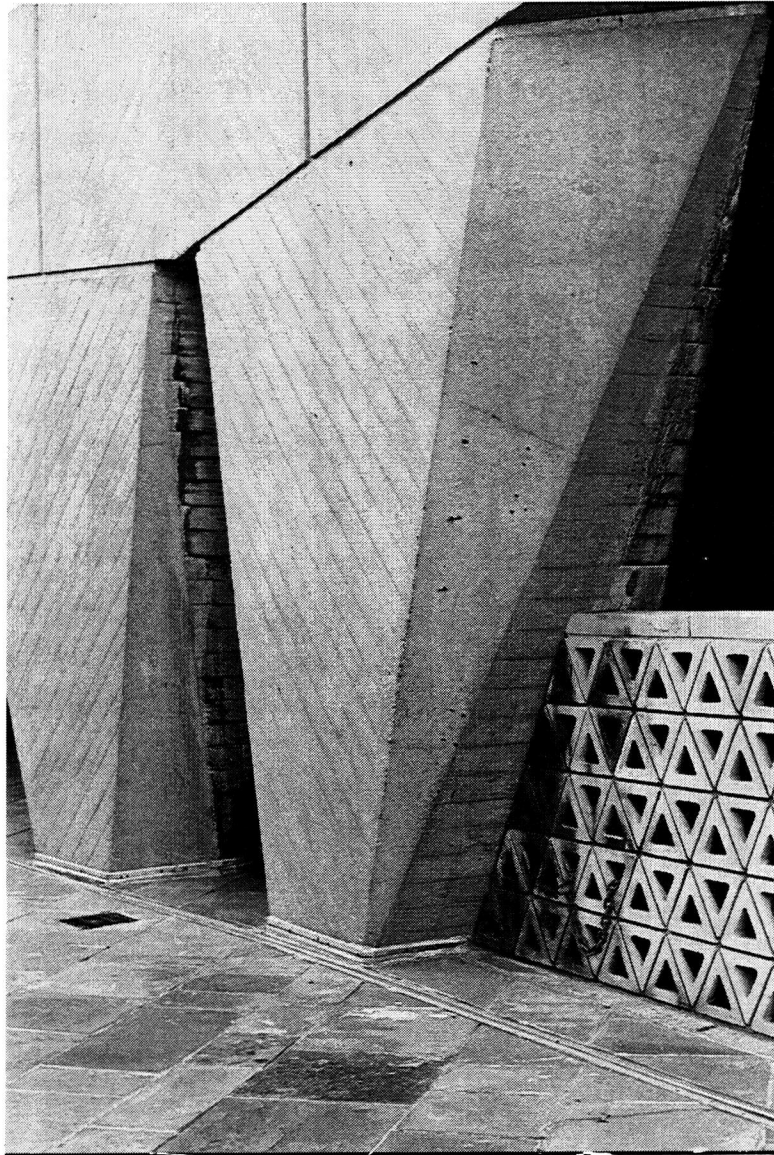
Illustration No. 6-3

Description: Detail of concrete tree and concrete triangular block screen wall. Note corroding stirrups (horizontal bars) and chairs (small dots) on concrete tree. Corroding reinforcing has split precast concrete coping on top of screen wall (see Chapter X, Guideline Specifications for Concrete Patching and Repair and Precast Concrete).

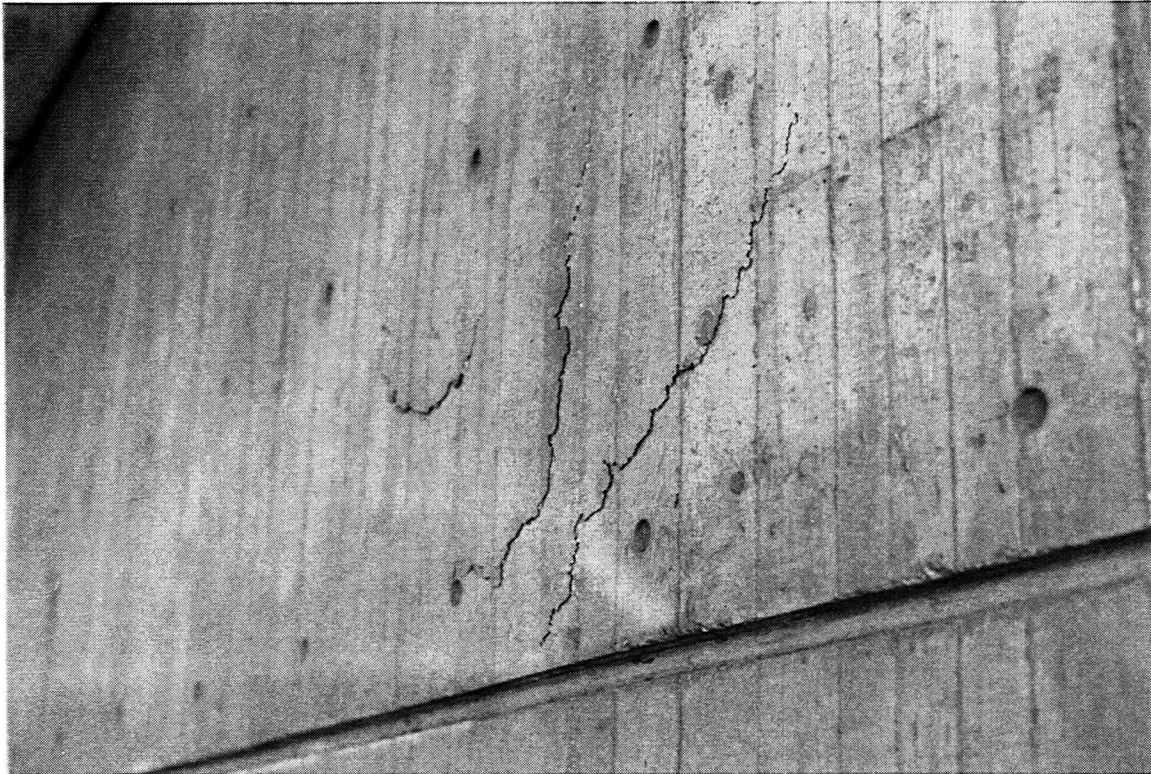
Illustration No. 6-5

Description: Spalling on concrete walls at air shaft opening to service drive is caused by corroding reinforcing in the wall (see Chapter X, Guideline Specification for Concrete Patching and Repair).

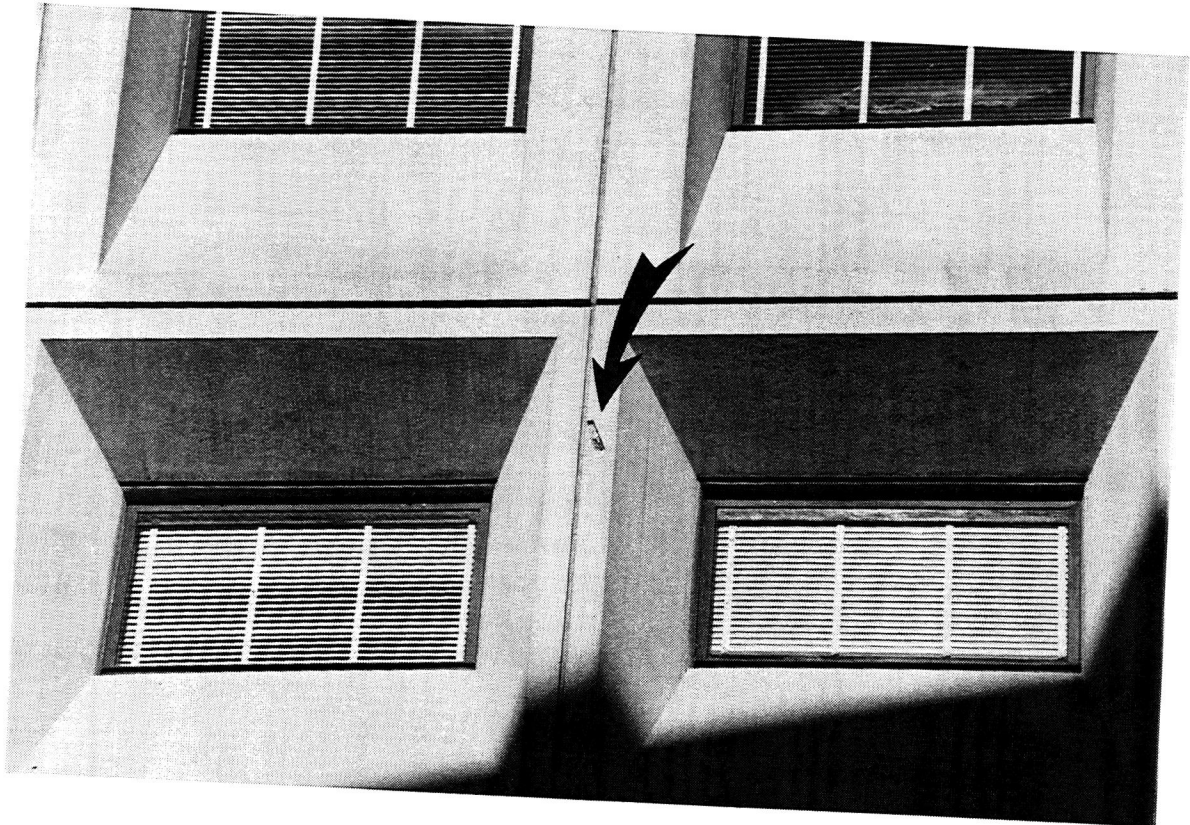
Illustration No. 6-6

Description: A wood scrap cast into the wall panel has deteriorated, leaving a void (see Chapter X, Guideline Specification for Concrete Patching and Repair).

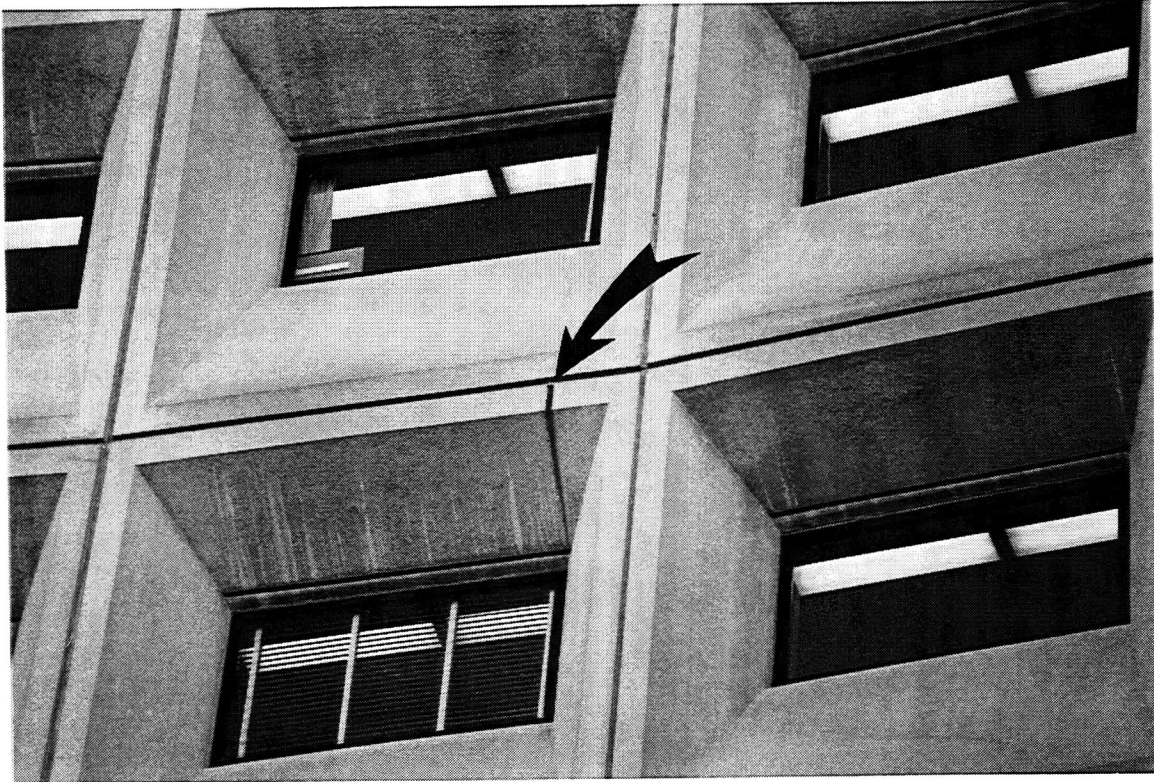
Illustration No. 6-7

Description: A piece of metal, possibly a bolt or fragment which had fallen into the panel formwork during construction, is corroding and staining the concrete window unit. Note also accumulated dirt on panels above window openings (see Chapter X, Guideline Specifications for Concrete Patching and Repair and Exterior Masonry Cleaning).

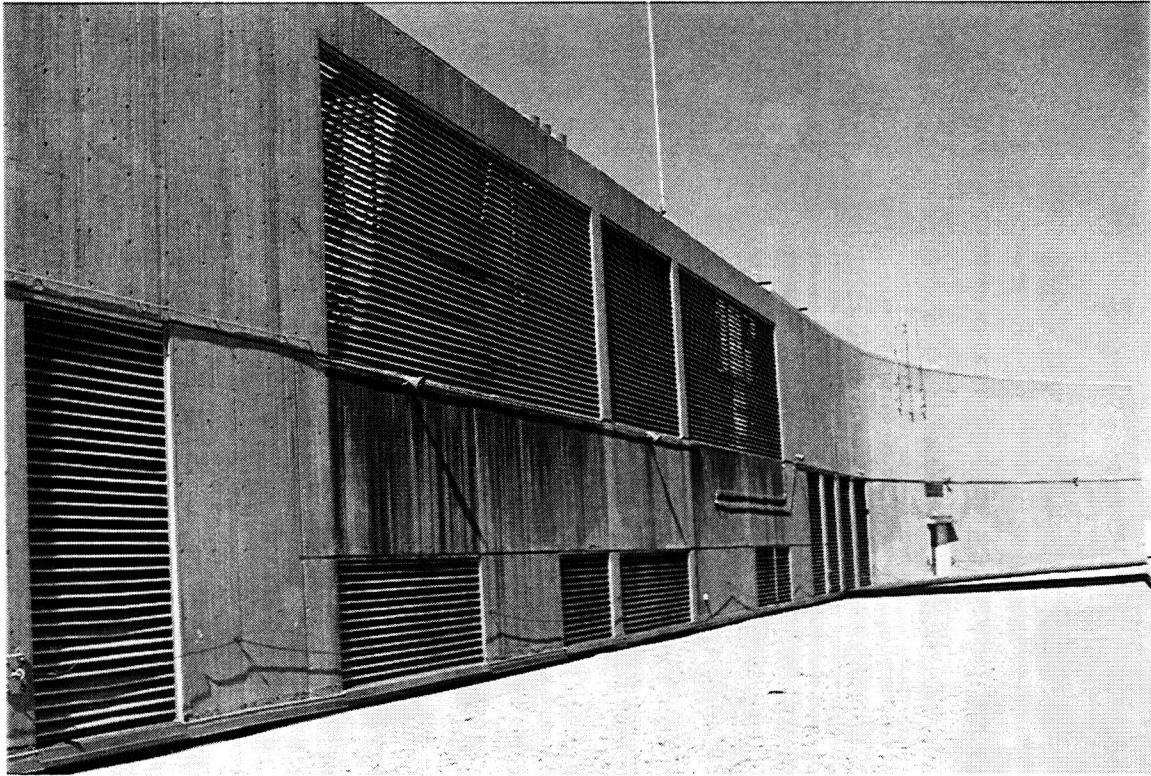
Illustration No. 6-9

Description: Concrete walls are dirty and stained below aluminum mill louvers. Dirt accumulating on the louvers is washing down and soiling the face of the wall below (see Chapter X, Guideline Specification for Exterior Masonry Cleaning).

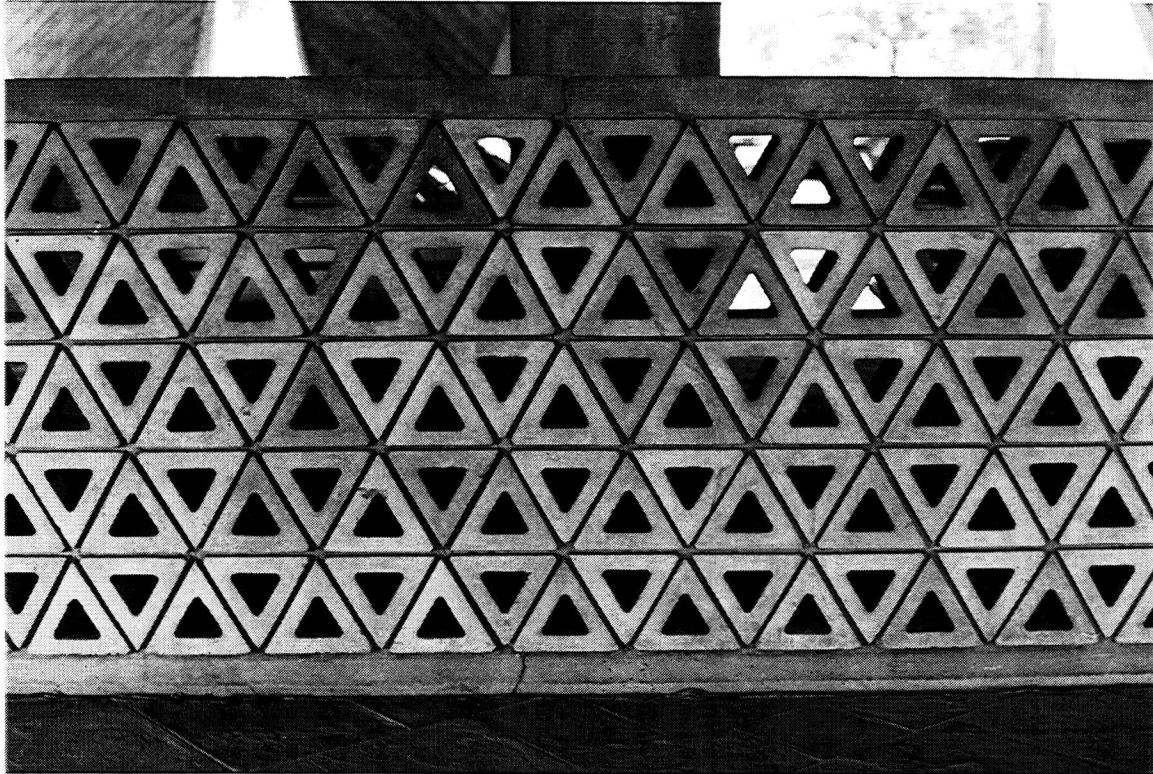
Illustration No. 6-10

Description: Detail of concrete triangular block screen wall. Crack extends through the concrete base and then follows the joints of the triangular units and coping. Crack occurs at the column line support of the building and is caused by the deflection of the structure on both sides of crack. Units are soiled from pollution and automobile exhaust (see Chapter X, Guideline Specifications for Precast Concrete and Exterior Masonry Cleaning).

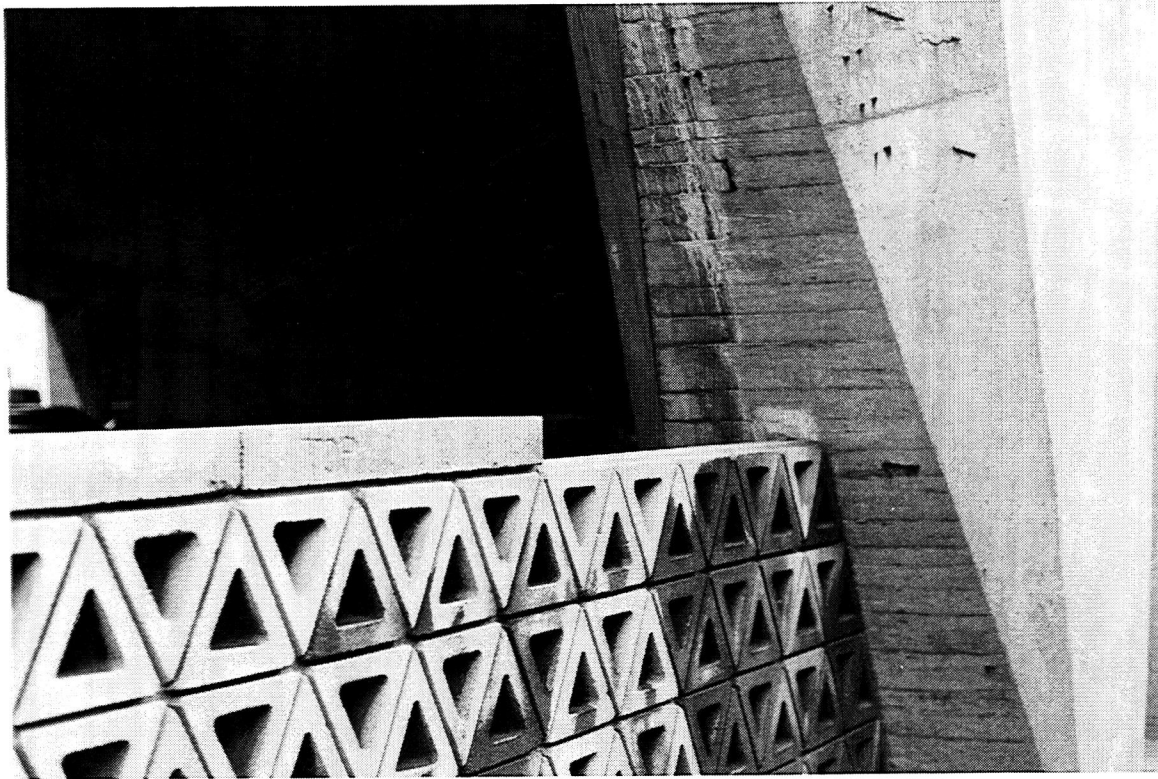
Illustration No. 6-11

Description: Concrete triangular block screen wall coping is missing. One piece of coping has been replaced with a precast concrete lintel cast with the word "TOP" (see Chapter X, Guideline Specification for Precast Concrete).

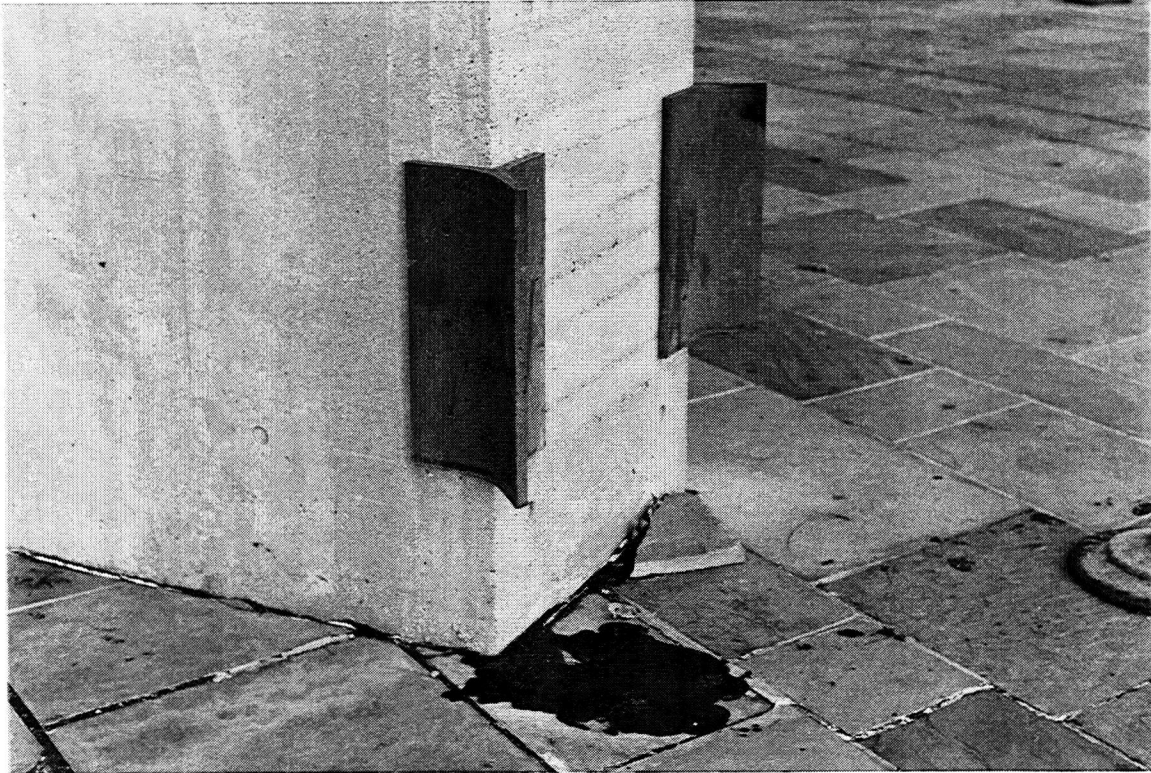
Illustration No. 6-15

Description: Detail of base of banner showing protective bronze castings. Bluestone paving has been stained by tar water proofing oozing up from around banner. The mortar joints in the paving is deteriorating (see Chapter X, Guideline Specification for Bluestone Paving, Repair and Replacement).

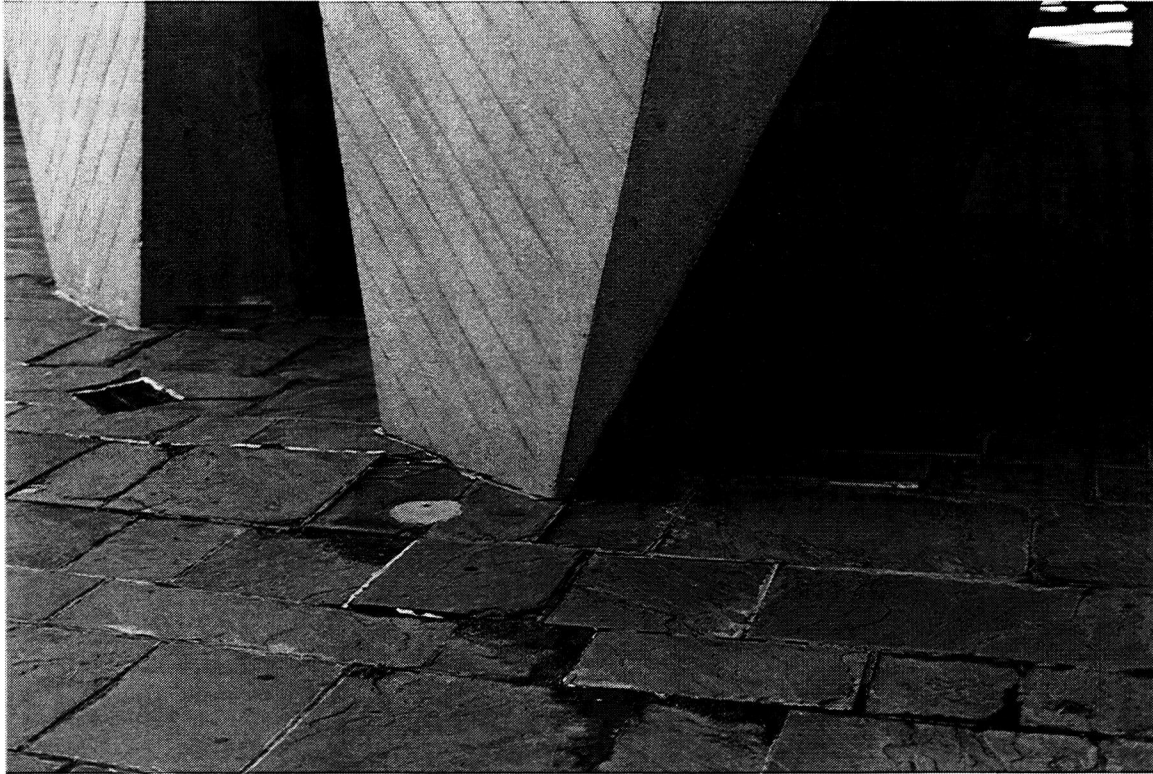
Illustration No. 6-16

Description: Detail of condition of bluestone paving on plaza. Pavers have settled, edges are cracked, stones are dirty, and have been caulked with inappropriate colored materials. Differential settlement between the building and the underground parking garage caused the pavers to shift, resulting in cracking at the joints and water ponding at the face of the building (see Chapter X, Guideline Specification for Bluestone Paving, Repair and Replacement).

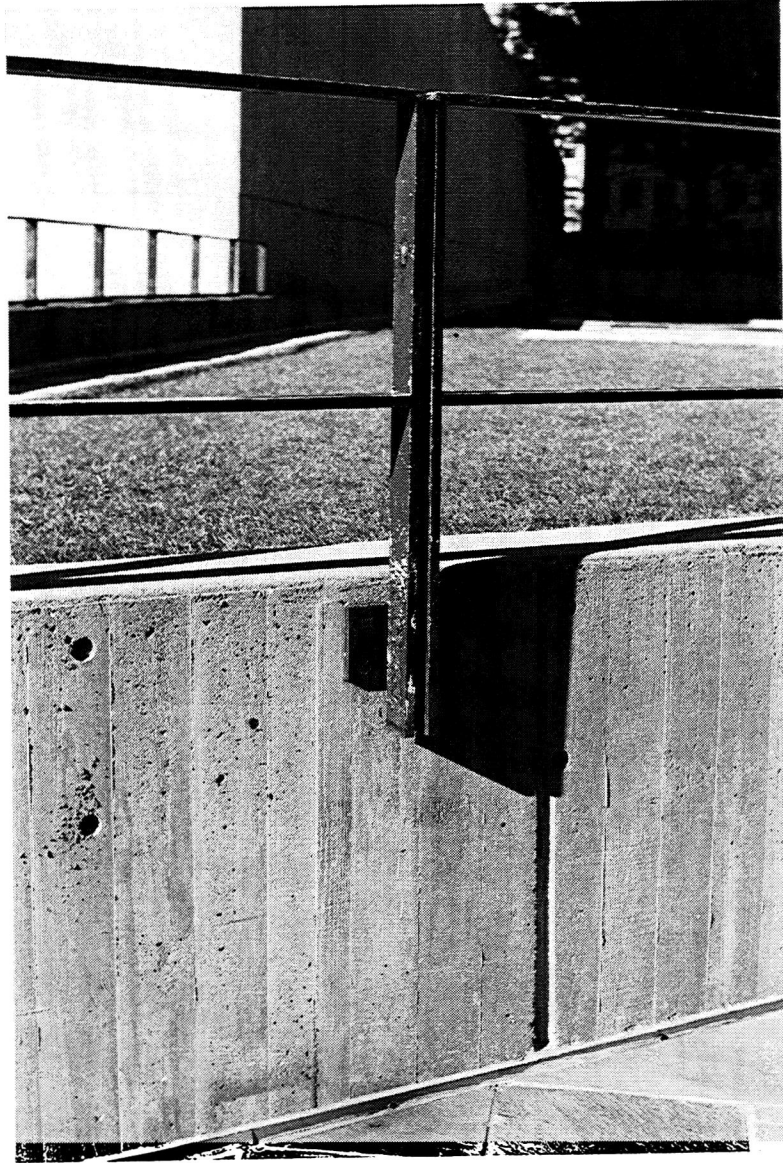
- Illustration No. 6-17
- Subject: Housing and Urban Development Building, West Elevation, South End
- Date: November 1994
- Description: Detail of metal railing located on retaining wall at raised grass covered knoll area. The railings are fabricated in welded sections of flat bar stock and attached to each other and the concrete wall with flat head screws. Metal is corroding due to failure of the paint coatings (see Chapter X, Guideline Specification for Exterior Painting).
- Photographer: Reed A. Black, AIA
- Source: Oehrlein & Associates Architects

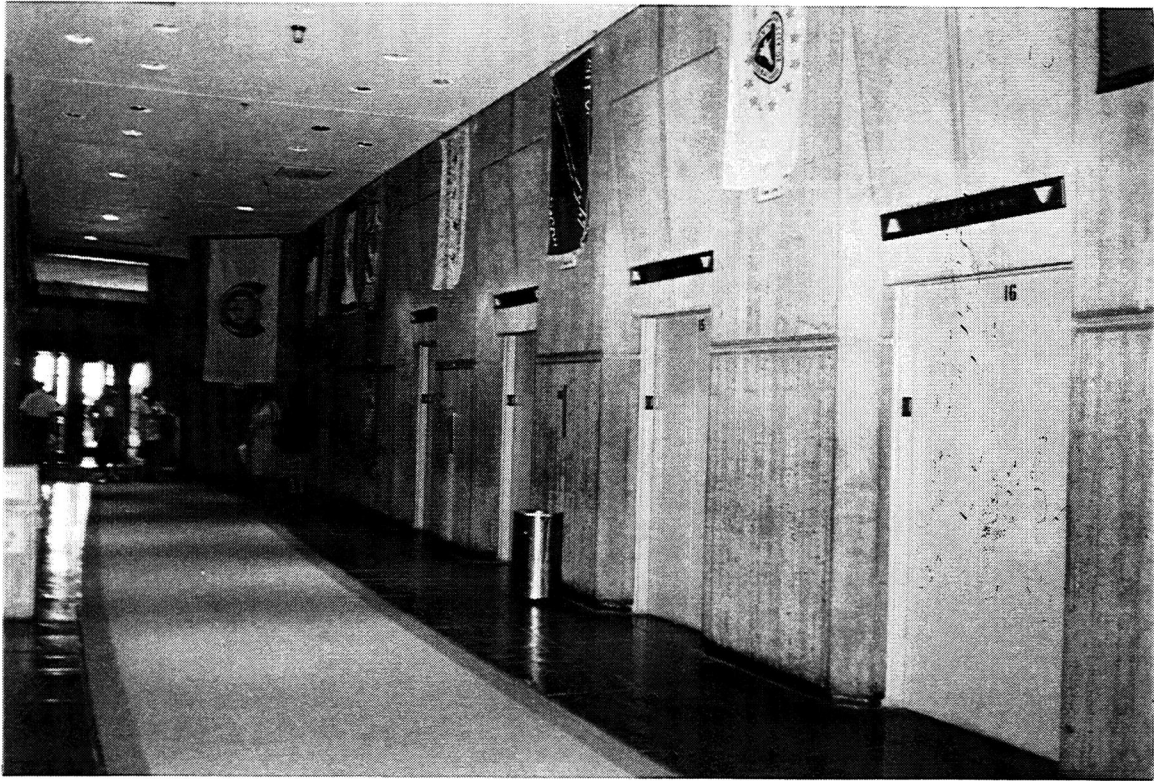
Illustration No. 6-18

Description: View looking west. Bluestone paving has been coated with multiple coats of wax; floor finish has been smeared up onto recessed concrete wall bases; concrete walls are dirty; original elevator "UP" and "DOWN" signs have been replaced with single UP/DOWN floor indicator sign; dark gray painted elevator doors and frames have been repainted light gray with elevator number stencilled on the door; white cement plaster original ceiling has been replaced with gypsum board; and wall hung ashtray has been removed and replaced with a floor can (see Chapter X, Guideline Specifications for Bluestone Paving, Cleaning and Finishing, Interior Masonry Cleaning, and Interior Painting).

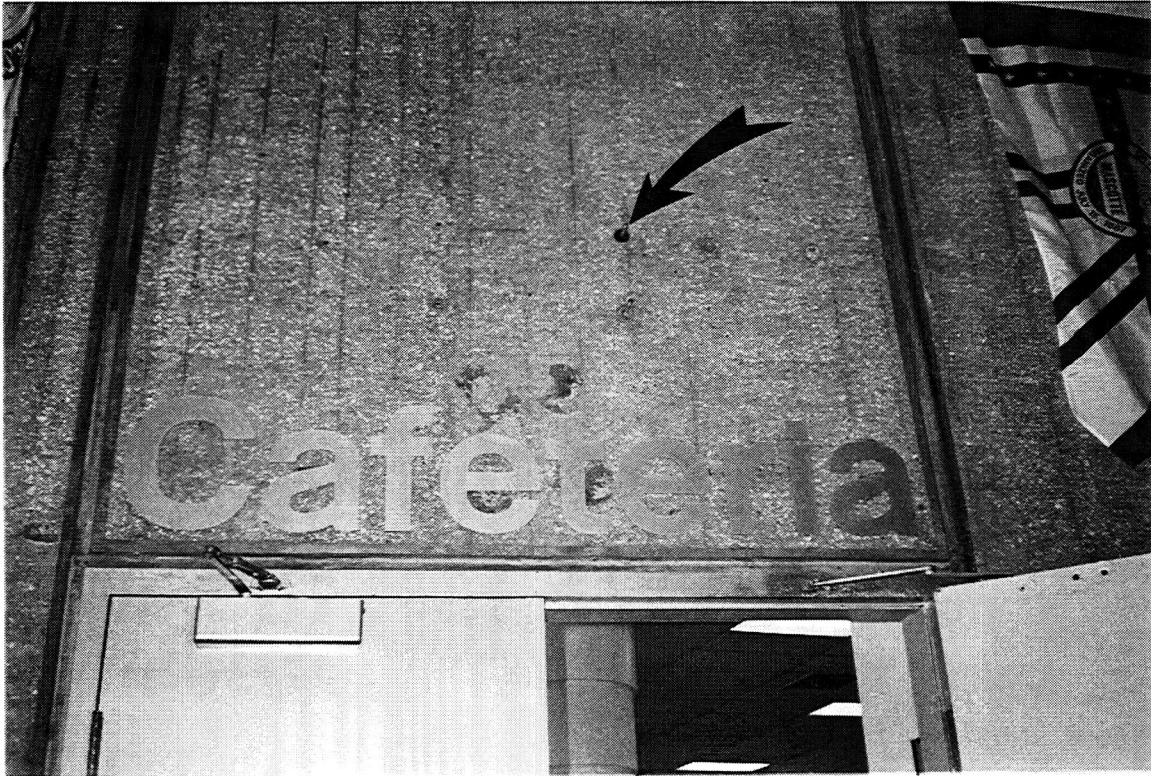
Illustration No. 6-19

Description: Detail of bushhammered concrete wall above entrance to cafeteria. Note recessed joints around panels, 1 inch smooth finished margin between joint and bushhammered face of panel and faint vertical lines from form boards on face of panel. Large silver colored plastic letters have been added above double doors. Stains remain on the concrete where sign was placed earlier; note also a protruding metal bolt from which a sign was hung (see Chapter X, Guideline Specification for Interior Masonry Cleaning).

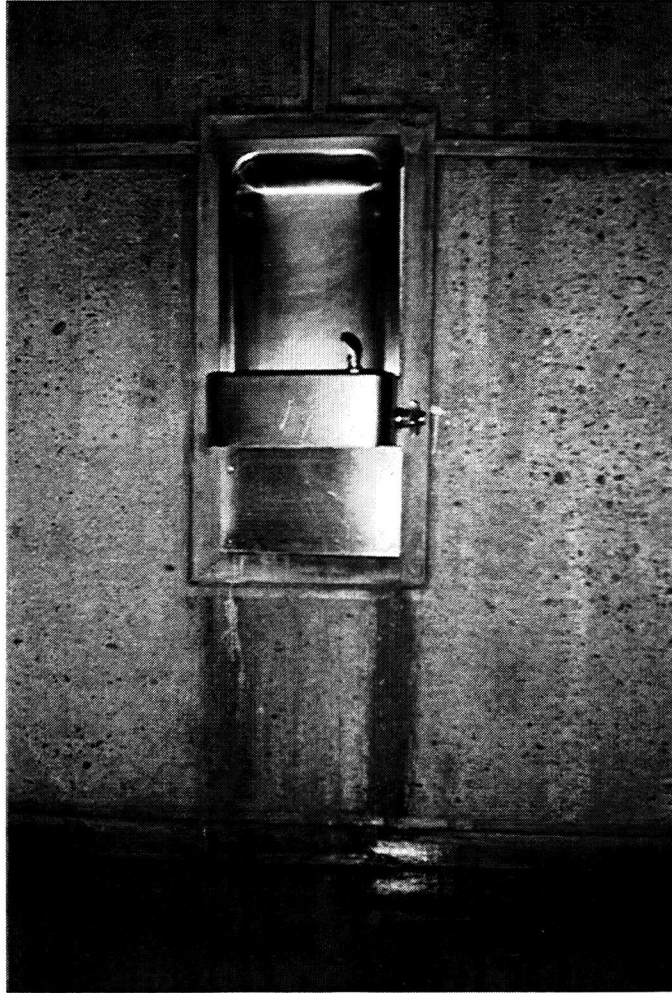
Illustration No. 6-20

Description: Water leak has caused staining beneath the drinking fountains in the northeast core area of the building on all floors (see Chapter X, Guideline Specification for Interior Masonry Cleaning).

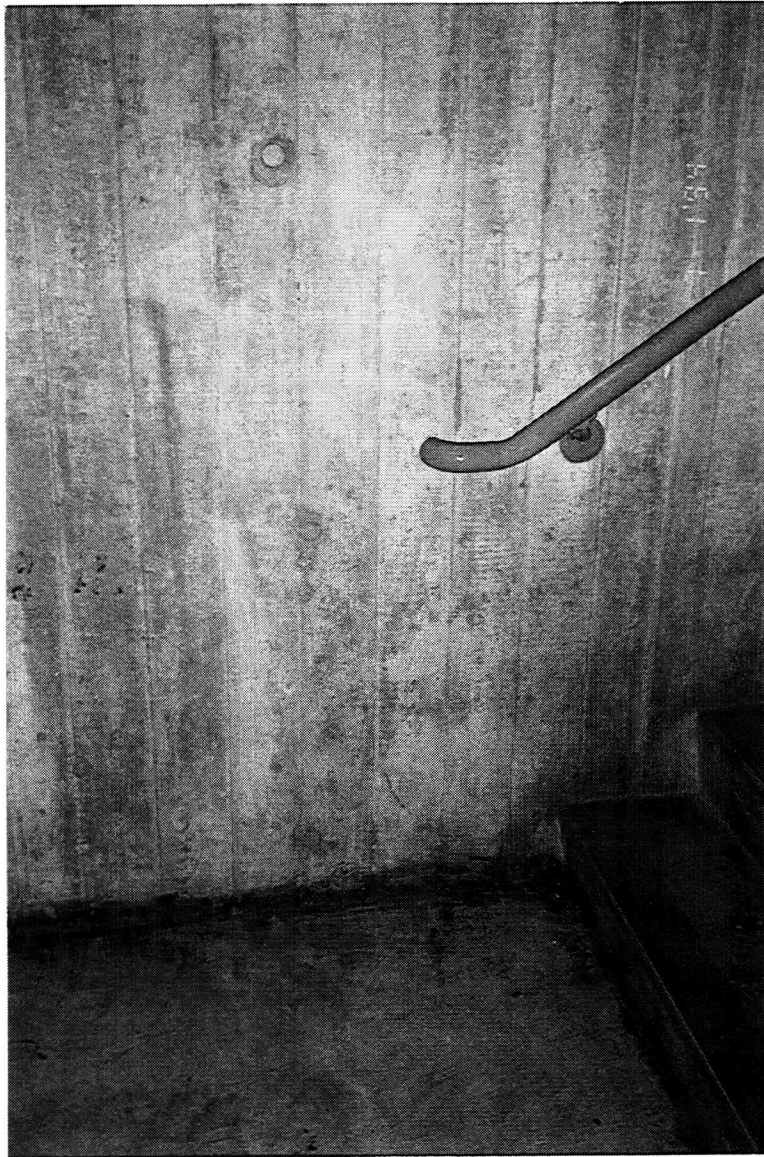
Illustration No. 6-21

Description: Sealer applied to concrete landings, stairs and risers has been splashed up onto concrete walls. Walls and edges of landings, stairs and risers are stained and dirty. Metal pipe handrail has recently been painted (see Chapter X, Guideline Specification for Interior Masonry Cleaning).

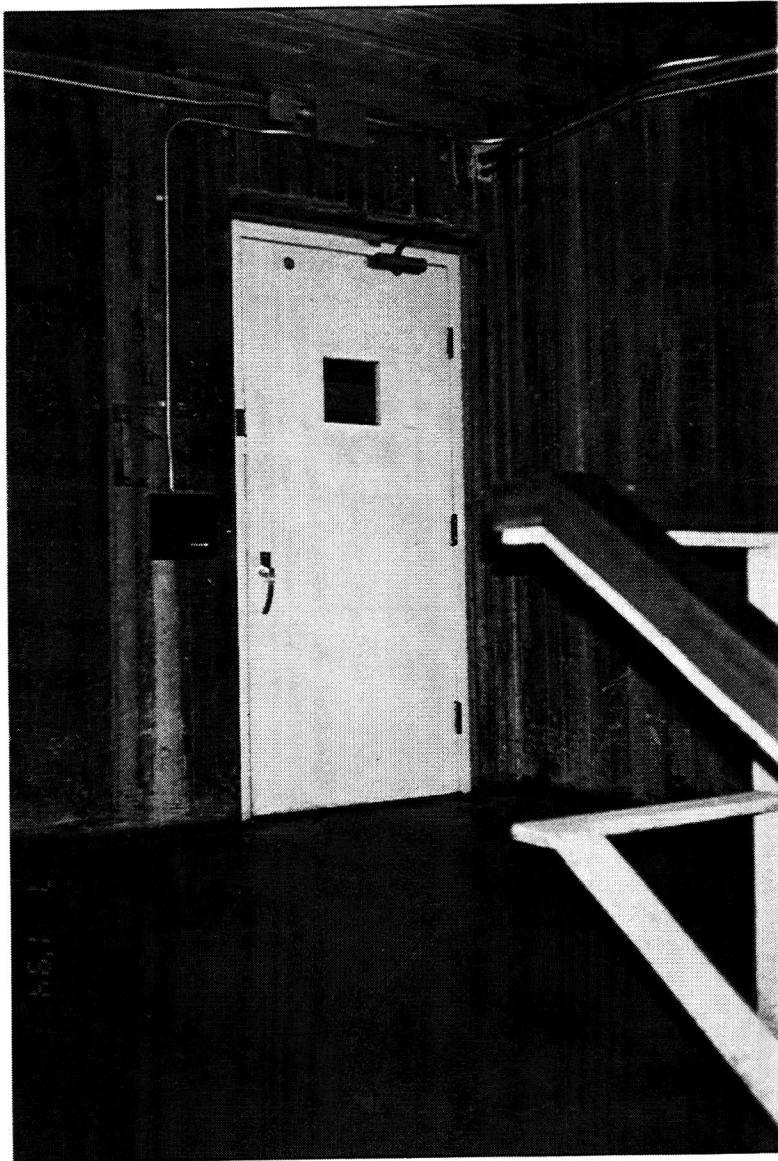
Illustration No. 6-22

Description: Landing on basement level. Note conduit which has been added to walls for access system and glue stains on wall above card access box. In foreground is cherry handrail which has a dirty and worn finish and painted metal railings (see Chapter X, Guideline Specifications for Interior Masonry Cleaning and Wood Repair and Refinishing).

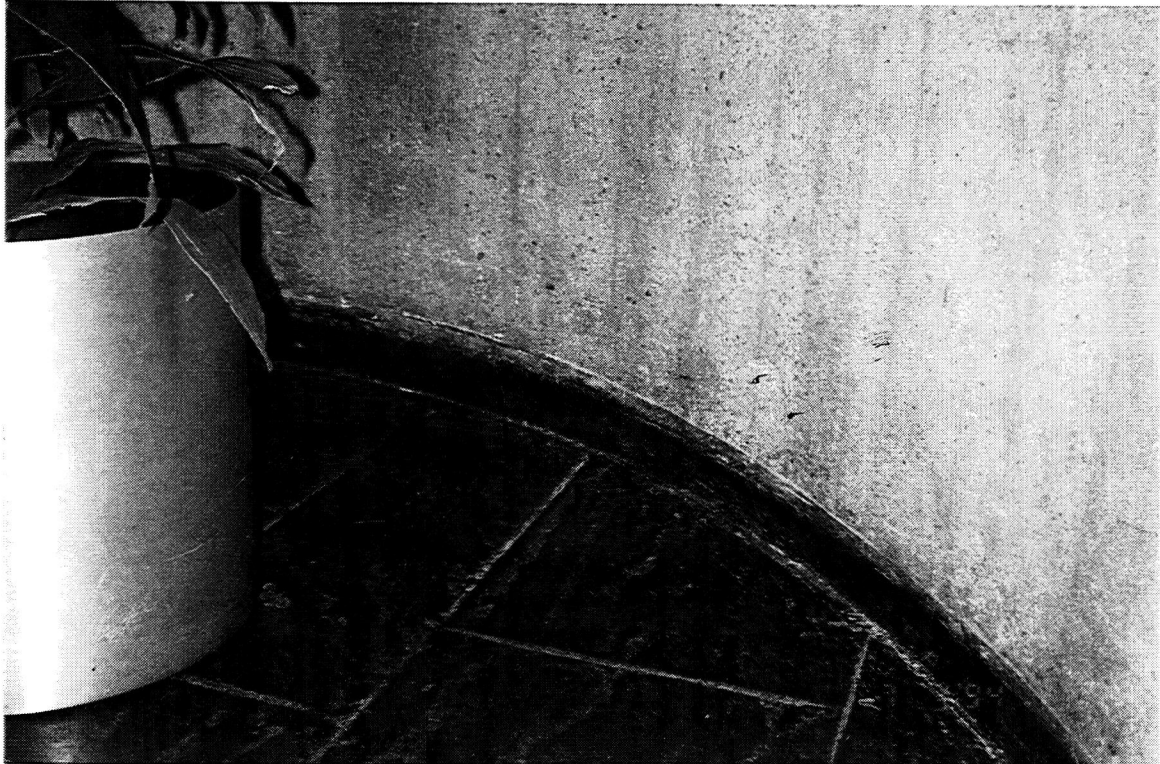
Illustration No. 6-24

Description: Detail of bluestone flagging and recessed concrete wall base. Finish applied to bluestone has been splashed up and stained the recessed concrete wall base (see Chapter X, Guideline Specification for Bluestone Paving, Cleaning and Finishing).

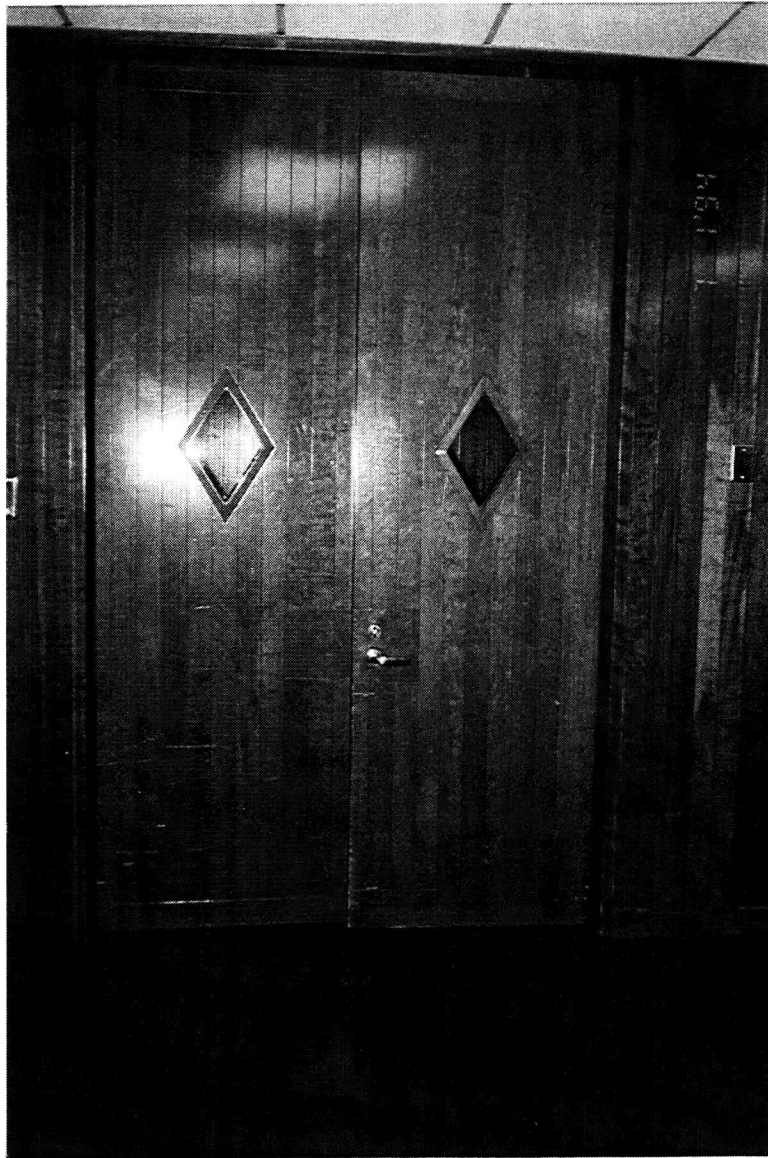
Illustration No. 6-25

Description: Hinge on doors between Foyer and Conference Room has failed; doors do not close properly. Walls and doors are natural finish American Cherry 3 inch wide tongue and groove paneling. Cherry has been finished with a gloss varnish not matching the original matte finish of the wood (see Chapter X, Guideline Specification for Wood Repair and Refinishing).

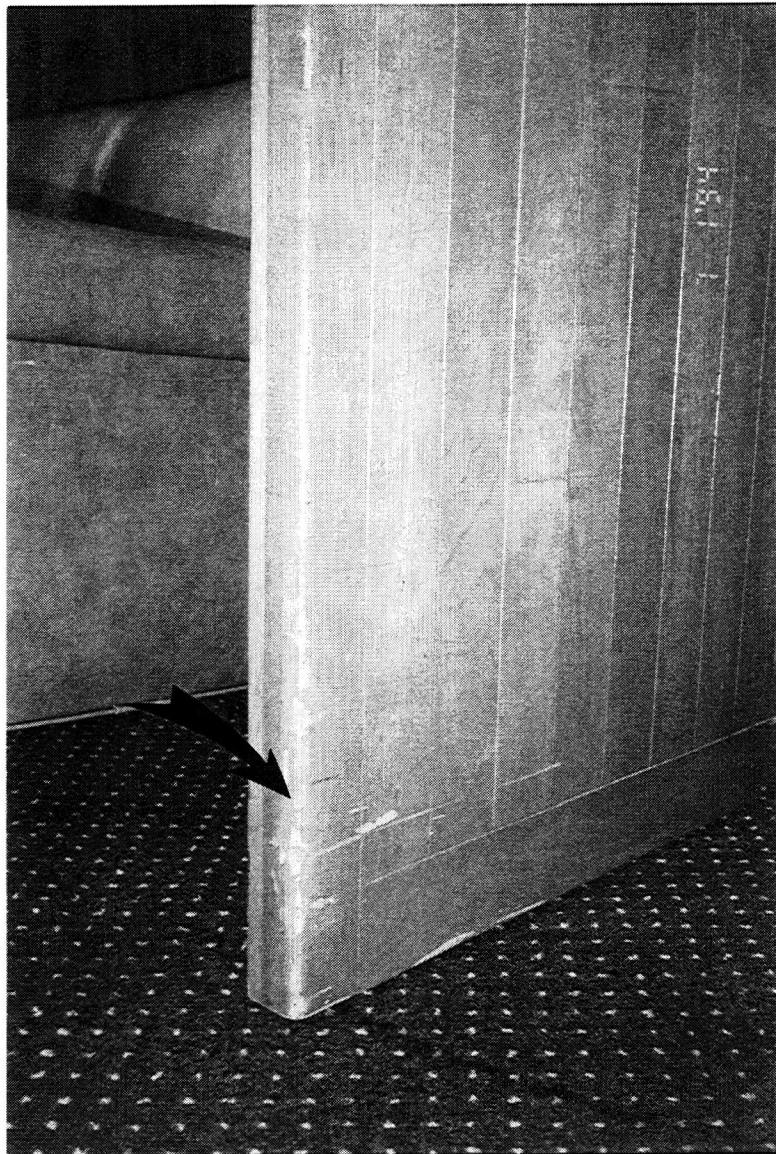
Illustration No. 6-26

Description: Detail of bottom of natural finish American Cherry 3 inch wide tongue and groove paneling door between foyer and conference room, showing chips and gouges along edge (see Chapter X, Guideline Specification for Wood Repair and Refinishing).

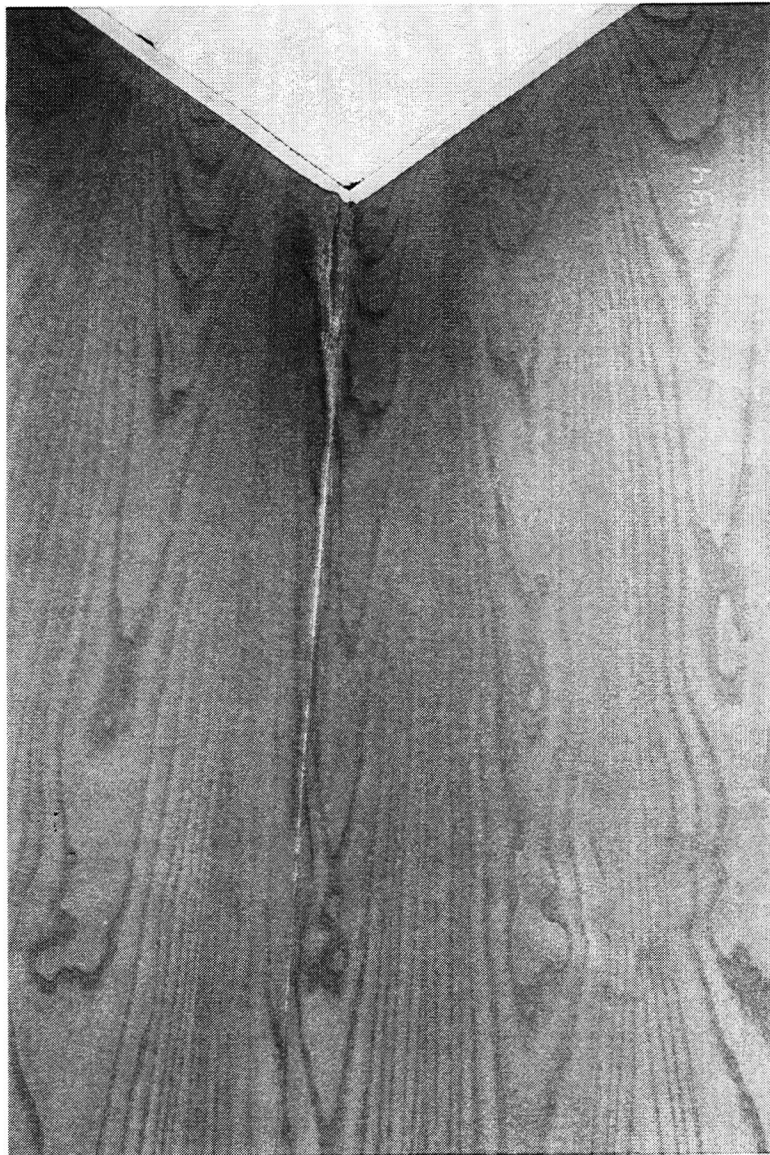
Illustration No. 6-28

Description: Southeast corner of building, finish of American Ash plywood paneling in northwest corner of room has been damaged due to a roof leak. Damage appears old; roof leak has been repaired (see Chapter X, Guideline Specification for Wood Repair and Refinishing).

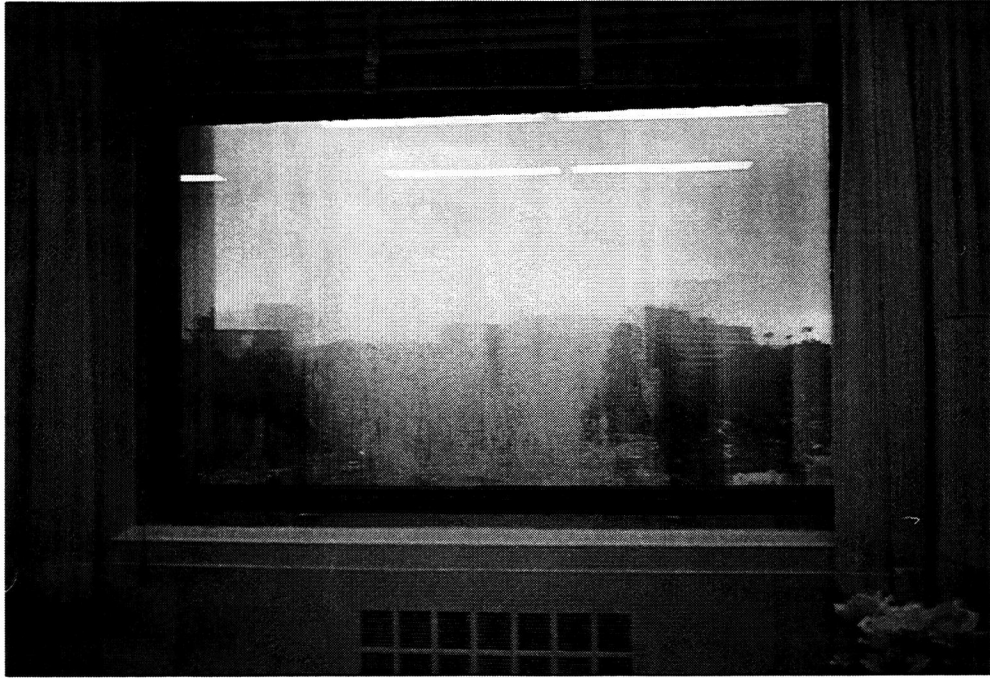
Illustration No. 6-29

Description: Heavy condensation on window, which according to occupants, is a common occurrence. The window also shows a great deal of scale build-up caused by the excessive moisture on the aluminum sash. Cold air from malfunctioning fan coil unit below window appears to be the cause (see Chapter X, Guideline Specification for Window Cleaning and Reglazing.)

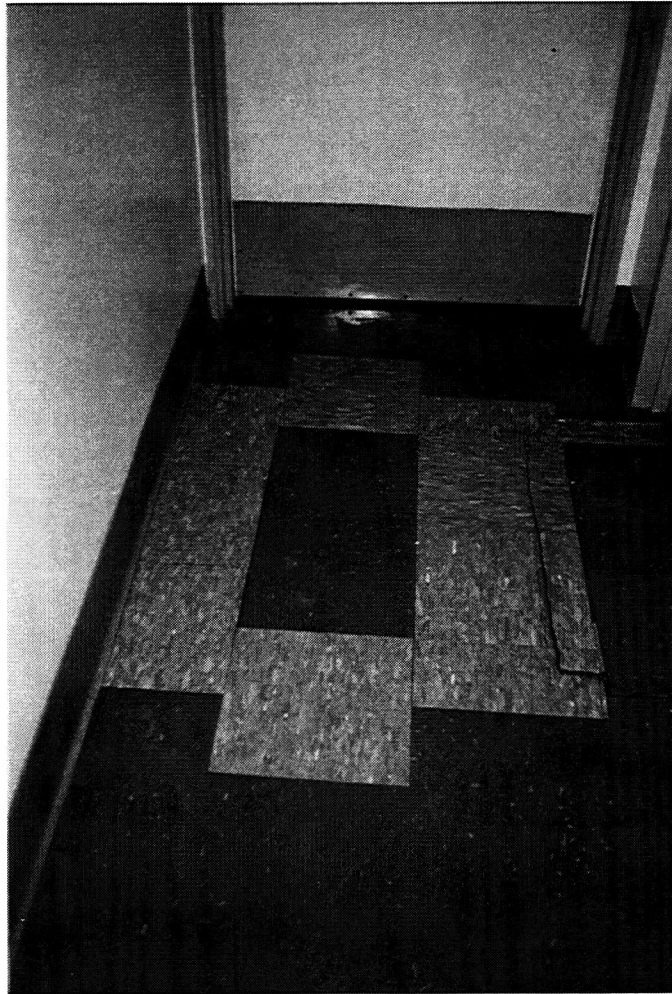
Illustration No. 6-30

Description: Damaged floor tile has been replaced with non-matching tiles; new tile has also developed a large crack (see Chapter X, Guideline Specification for Vinyl Flooring Replacement).

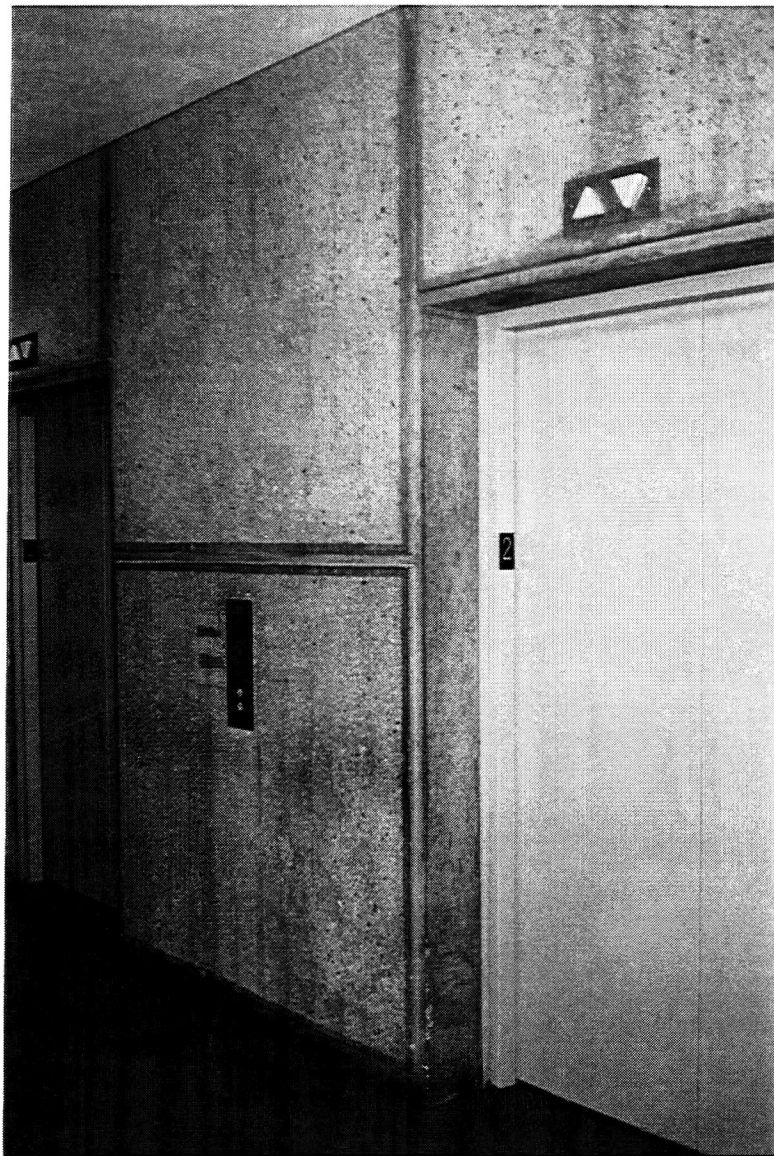
- Illustration No. 6-32
- Subject: Housing and Urban Development Building, Second Floor Elevator Lobby
- Date: November 1994
- Description: Detail of concrete wall and elevator door. Concrete walls are soiled and there are tape stains adjacent to elevator call buttons. Original elevator "UP" and "DOWN" signs have been replaced with single UP/DOWN floor indicator sign; dark gray painted elevator doors and frames have been repainted light gray with elevator number stencilled on the door. Note recessed joints around panels, 1 inch smooth finished margin between joint and bushhammered face of panel and faint vertical lines from form boards on face of panel. Concrete jambs and head of door openings are also smooth finished (see Chapter X, Guideline Specification for Interior Masonry Cleaning).
- Photographer: Craig Ackerman
- Source: Oehrlein & Associates Architects
