CHAPTER VI

MATERIALS CONSERVATION ANALYSIS

The materials conservation analysis on the Housing and Urban Development (HUD) Building at 451 7th Street, SW, Washington, DC (Building #DC0092ZZ), was prepared between June and December of 1994. The purpose of this analysis is to provide the information required to stabilize, preserve, restore and maintain the significant materials of the building. Restoring and preserving the original appearance of the building's materials and details will return the building to its original appearance, thus expressing the original intent of the administration and designers who created the building. Proper maintenance will preserve the appearance of the materials, thus slowing the rate of deterioration and substantially extending the building material's life.

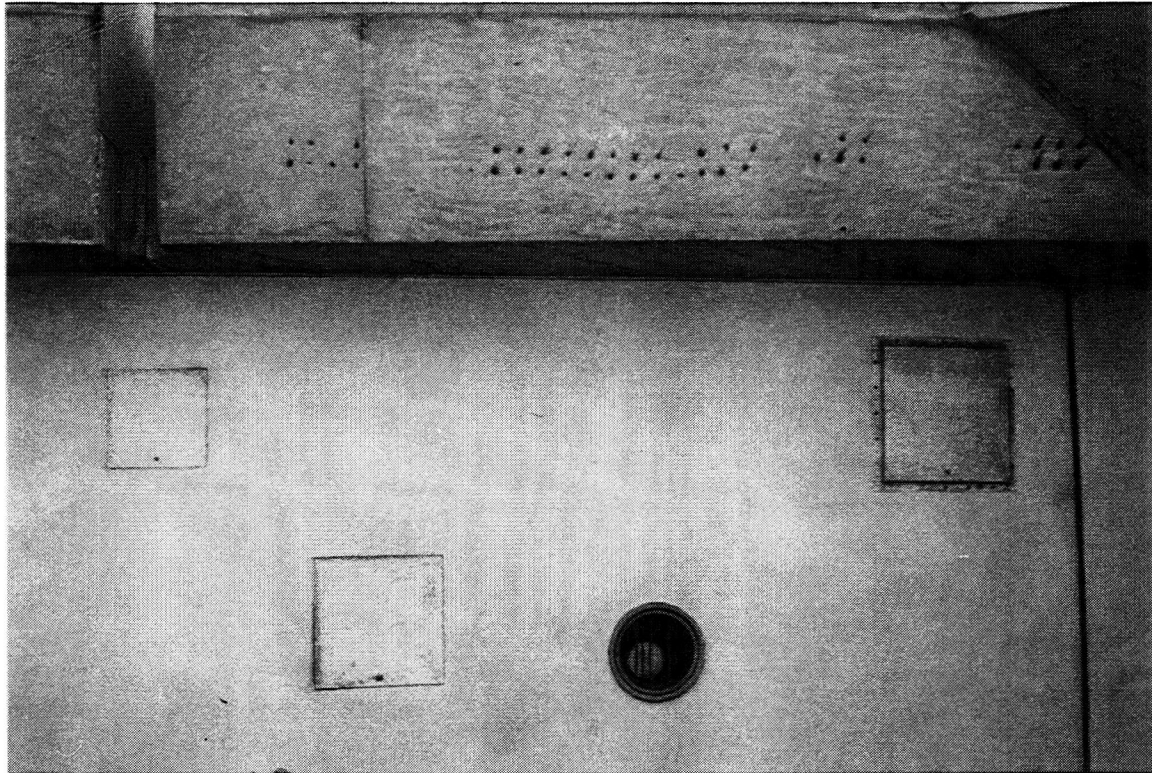
Illustration No. 6-35

Description: Original plaster ceiling of the arcade is soiled. Original metal access panels are corroding due to failure of the paint finish. Original light fixture with original metal louvered lens can also be seen (see Chapter X, Guideline Specifications for Exterior Masonry Cleaning and Exterior Painting.)

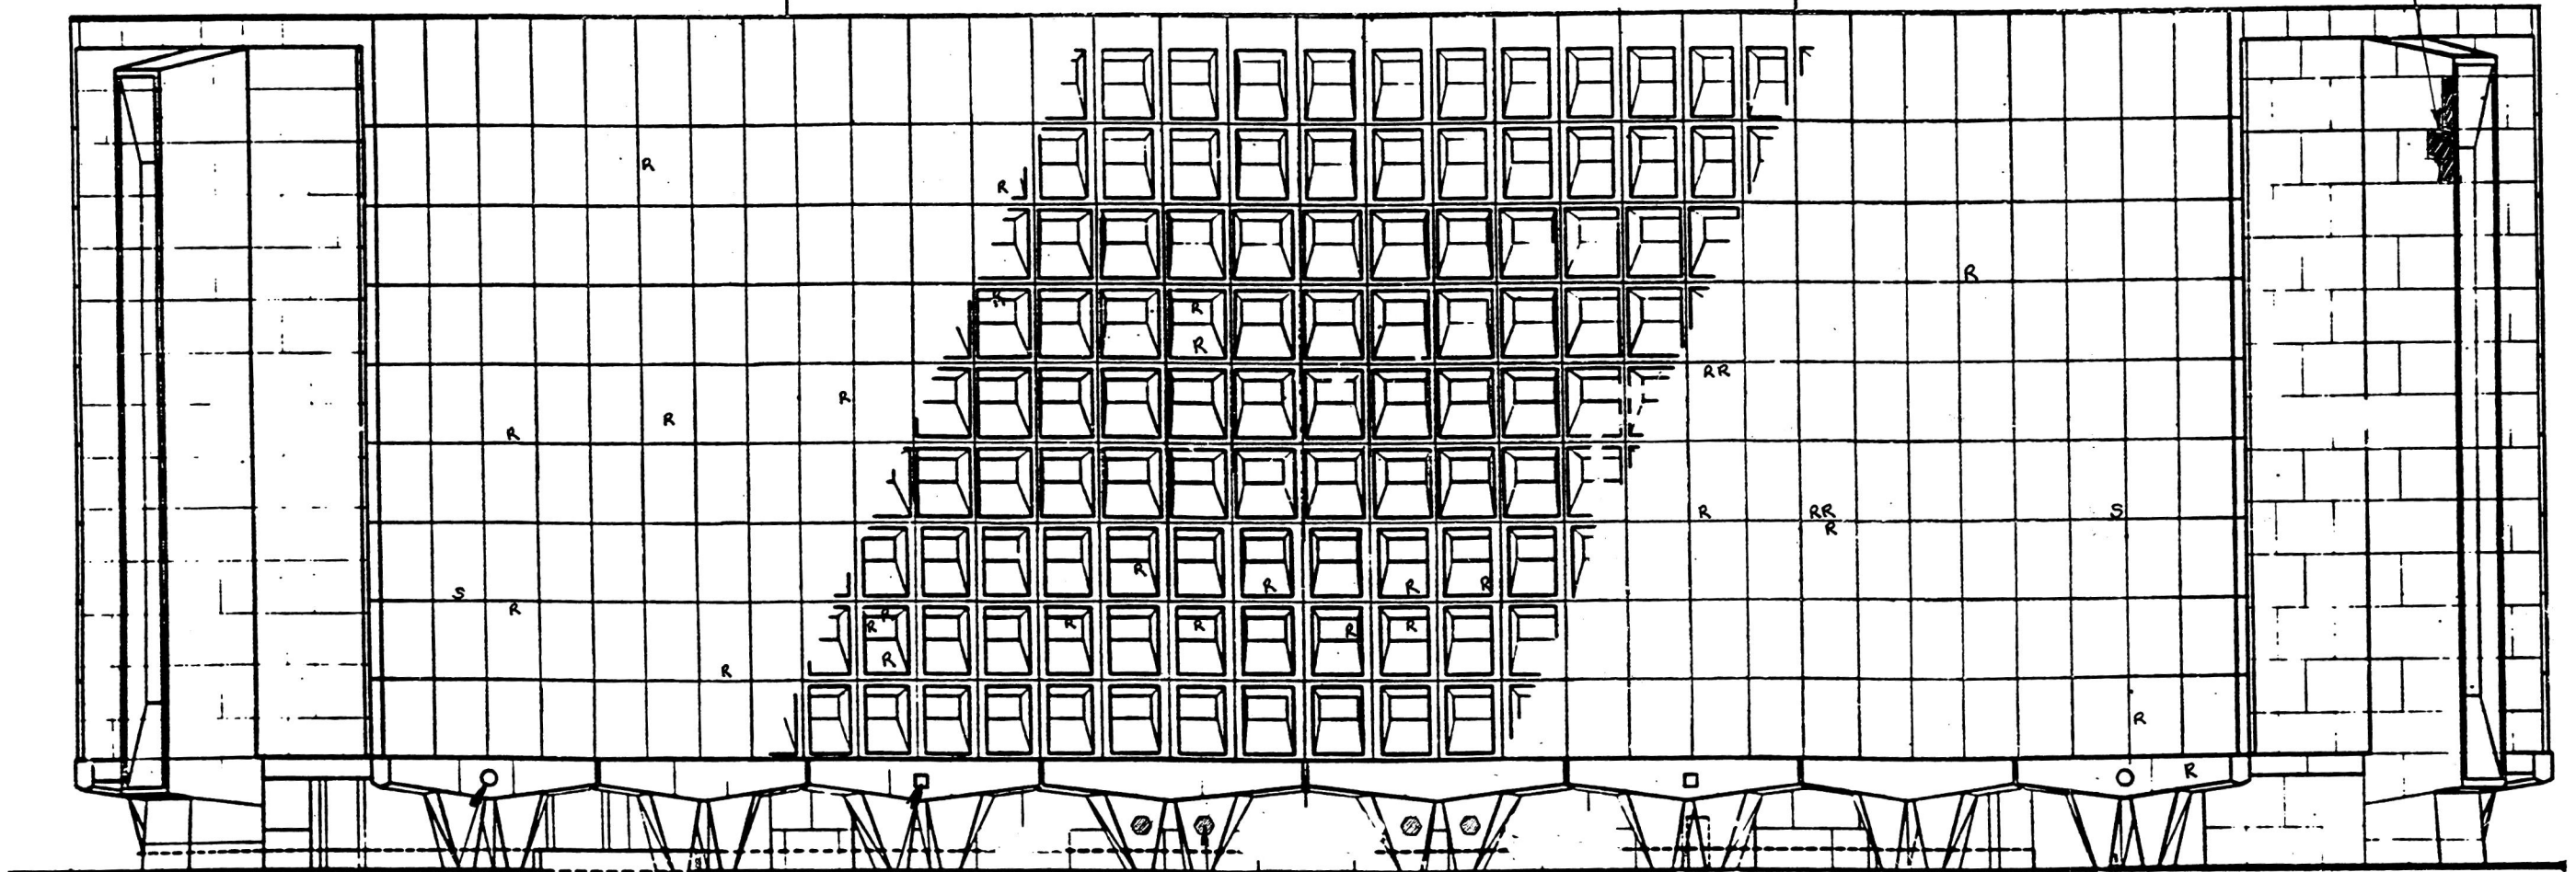
DISPLACED GRANITE - SEE ILLUSTRATION 6-44
